RICS Home Surveys Building Survey

39 Bentley Avenue, Bakersfield,
Nottingham, NG3 7AX

20th January 2021

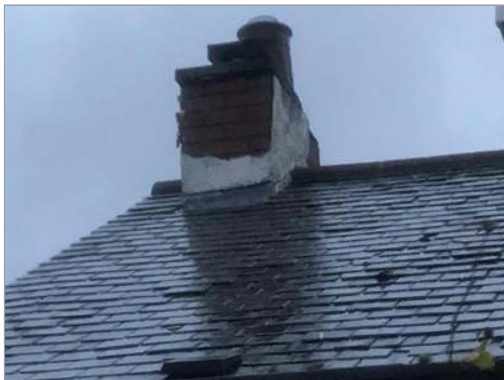
Photo - 1 Blown render noted to stack. Remove.

Chimneys are constructed of brick and require repointing, any spall bricks will require renewal. Lime based mortar should be used to repoint the chimneys to provide the flexibility required to survive the weathering change. The flashings should be redressed using coded lead material lapped into the joints to provide a firm fix against penetrative dampness. The roof covering and chimney stack may have to be disturbed to repair the flashing and this can increase the amount of work required.

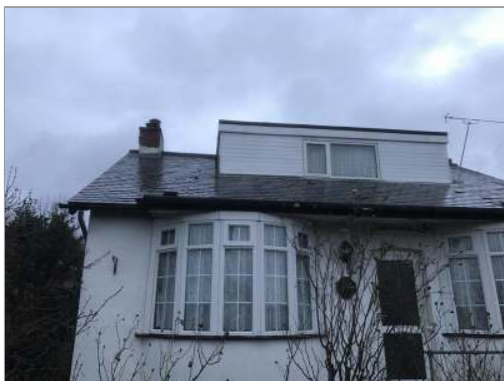
Photo - 4 Undulation noted to slated roof. Consider renewal for age related purposes.

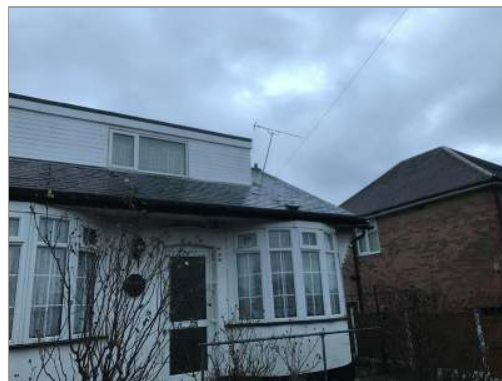
Photo - 5 Renew flashings around dormer.

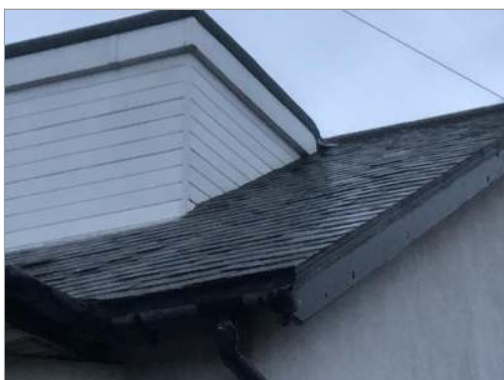
Photo - 6 Refix loose slates.

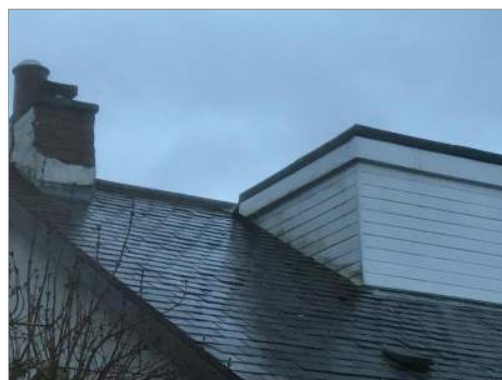
Photo - 7 Repoint ridge tiles.

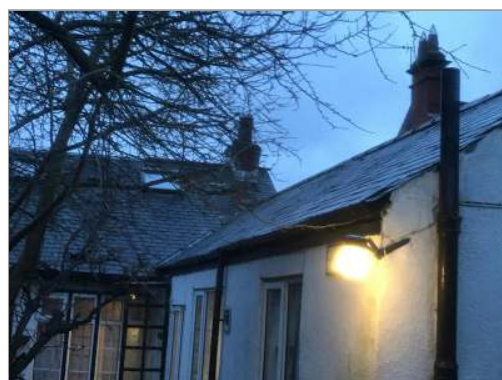
Photo - 9 Undulation noted to rear extension roof.

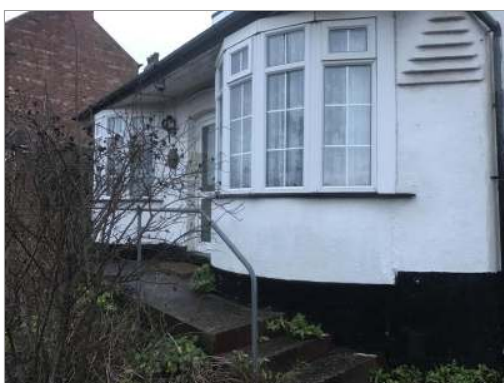
Photo - 16 Movement noted to front bay render.

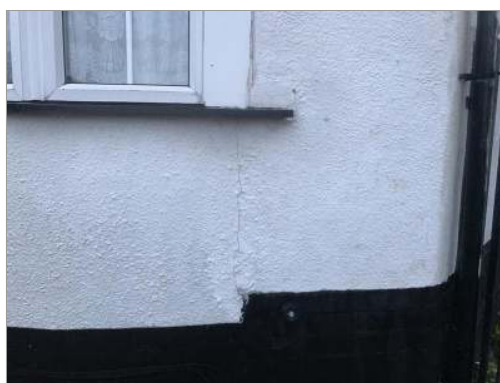
Photo - 17 Differential movement noted to front bay.

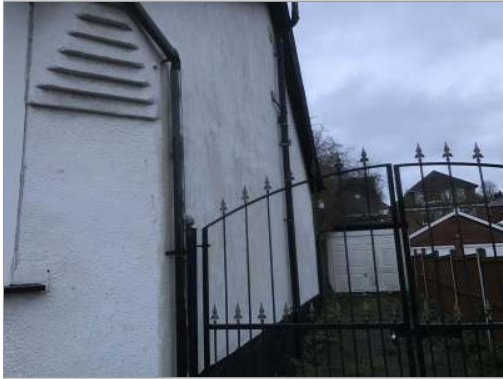
Photo - 18 Penetrative dampness noted to side elevation render.

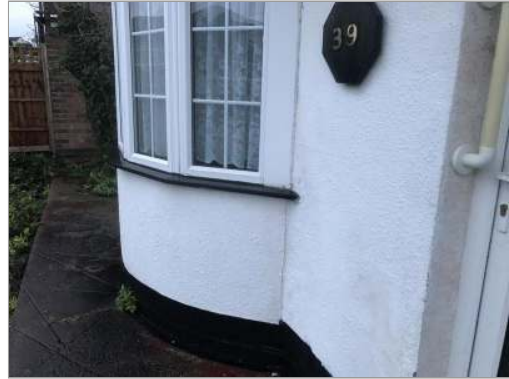
Photo - 19 Low level rising dampness noted to front elevation render.

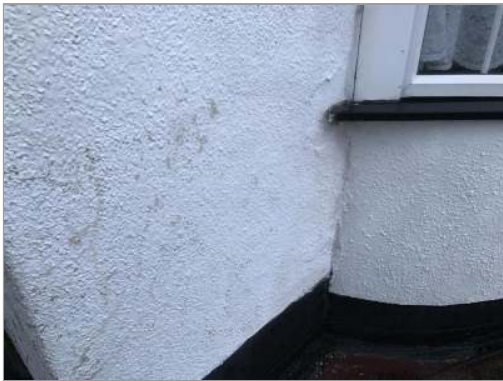
Photo - 20 Remnants of shrubbery growth evident to front elevation.

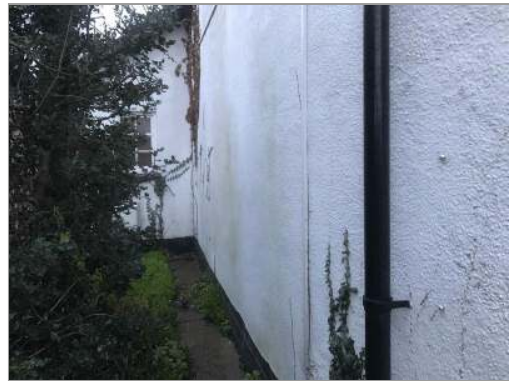
Photo - 21 More vegetation growth remnants noted to side elevation.

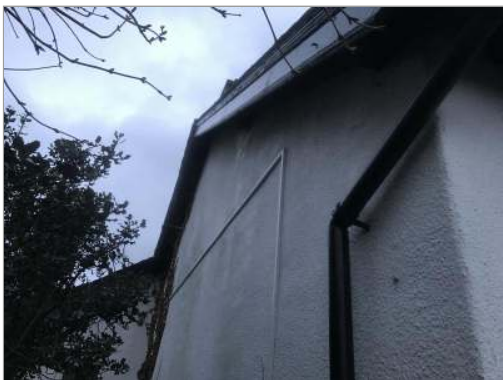
Photo - 22 Patch repairs evident to render.

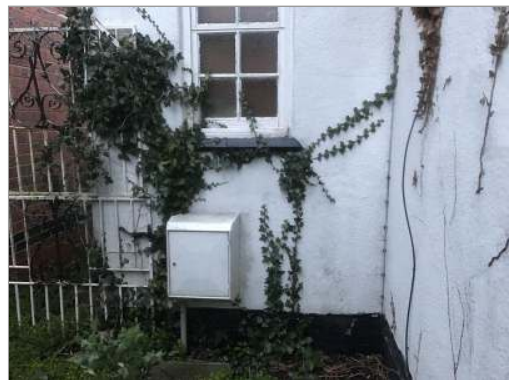
Photo - 23 Remove shrubbery growth from render.

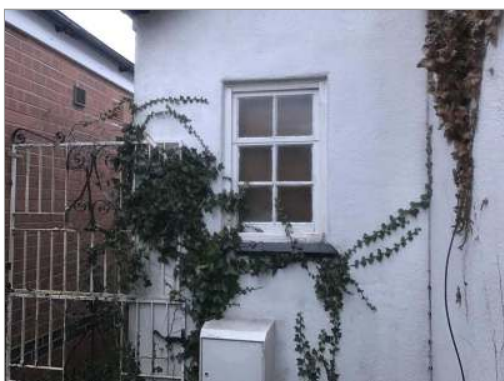
Photo - 24 Upgrade single glazed timber windows for thermal efficiency purposes.

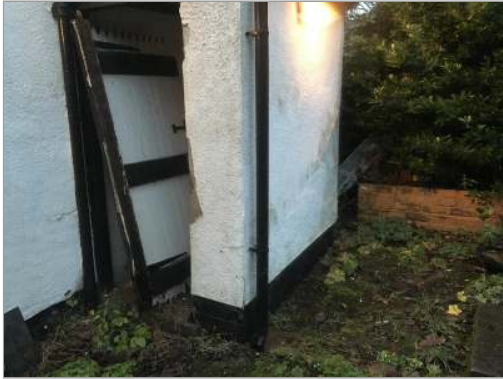
Photo - 26 Penetrative dampness noted to rendered walls.

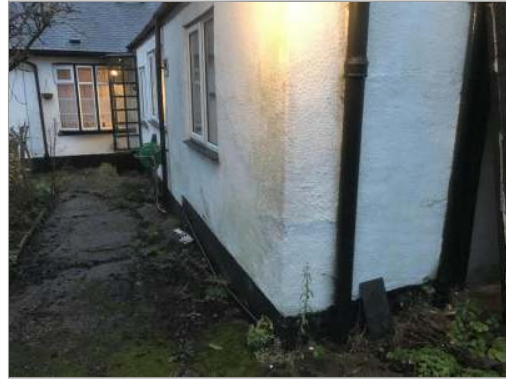
Photo - 27 More penetrative dampness noted.

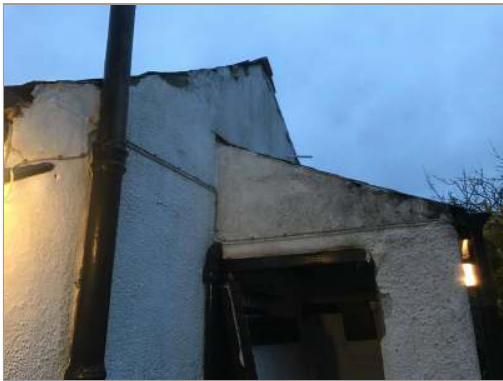
Photo - 28 Remove render and make good brickwork underneath or renew with insulated render.

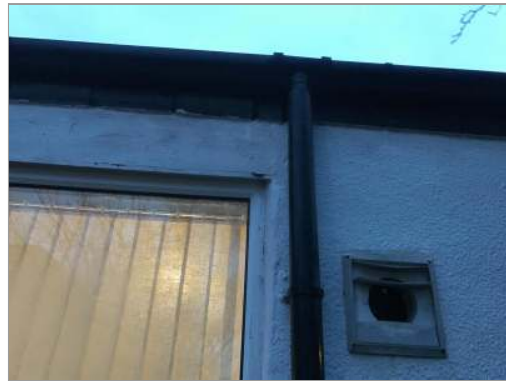
Photo - 29 Leaking gutters noted leading to penetrative dampness around openings.

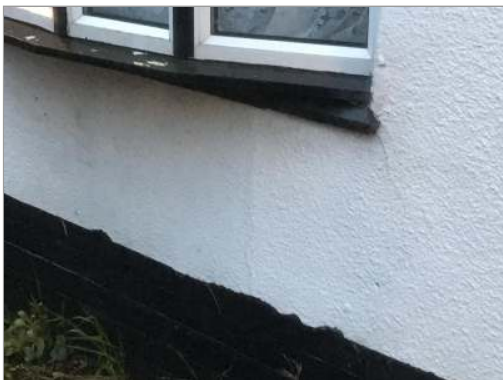
Photo - 30 Moderate movement noted to rear openings.

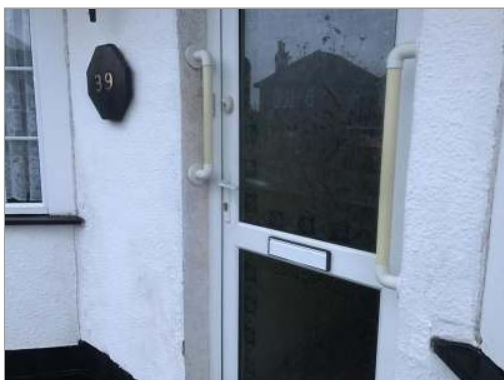
Photo - 31 Upvc front door noted. Ensure glazing is made shatterproof.

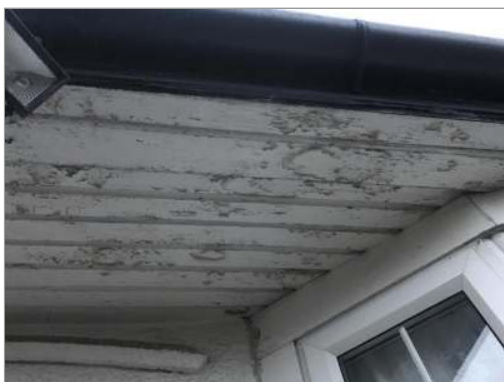
Penetrative dampness noted to timber soffits from eaves slates and leaking or blocked gutters.

Photo - 39 Penetrative dampness noted to timber soffits from eaves slates and leaking or blocked gutters.

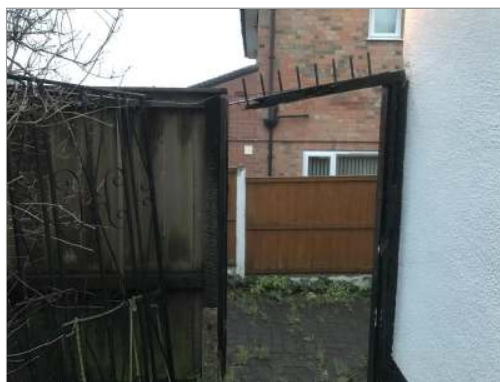
Remove nails to broken side gate frame to avoid various liability claims.

Photo - 40 Remove nails to broken side gate frame to avoid various liability claims.

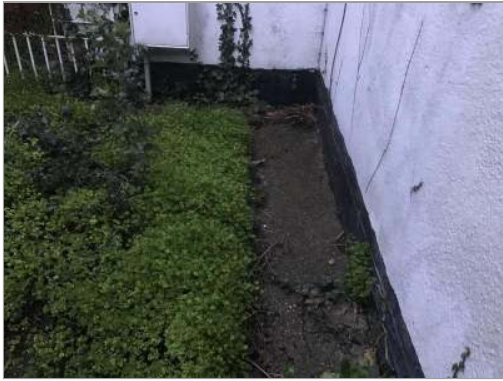
Photo - 46 Resurface worn concrete path to rear side elevation.

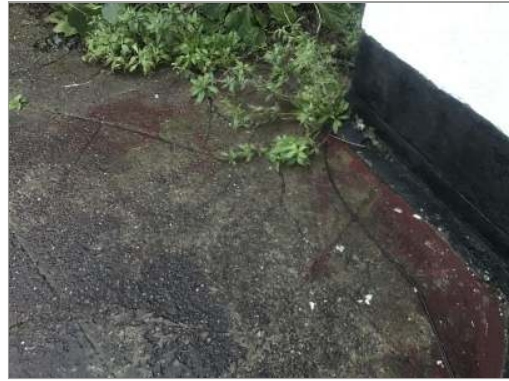
Photo - 47 Remove vegetation growth and check for invasive weeds.

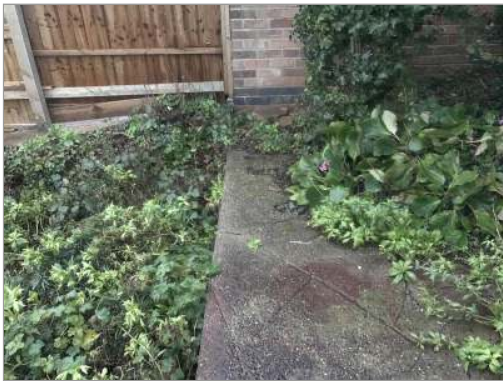
Photo - 48 Resin repairs required to cracked path.

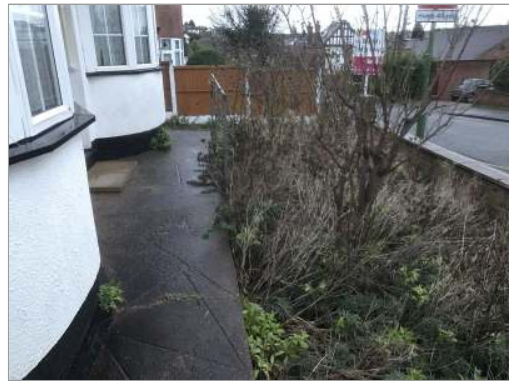
Photo - 49 Resin repairs required to cracked path to front.

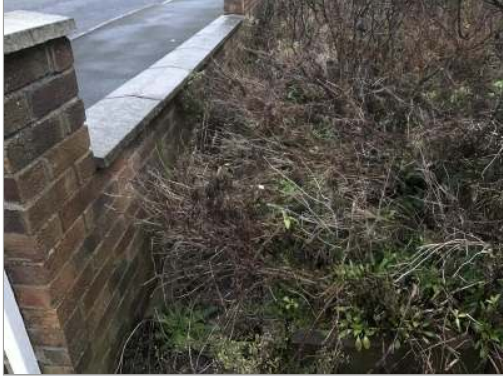
Repoint copings and worn mortar to brickwork to front boundary wall.

Photo - 50 Repoint copings and worn mortar to brickwork to front boundary wall.

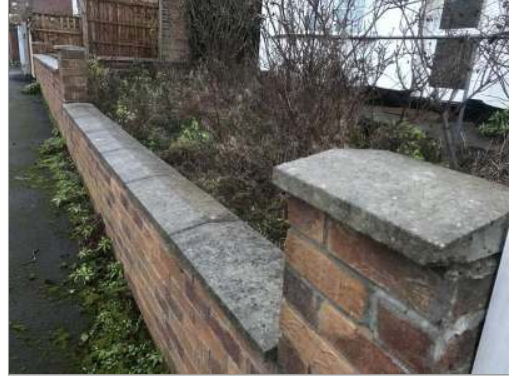
Photo - 51 Realign copings.

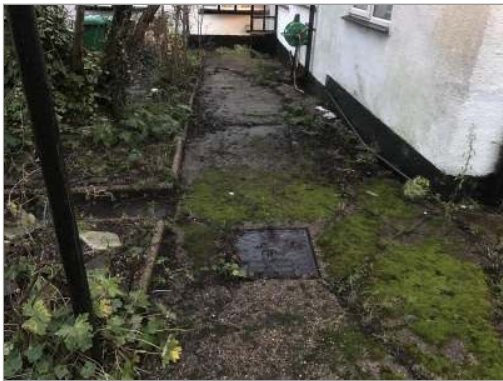
Photo - 54 Resurface broken front side path.

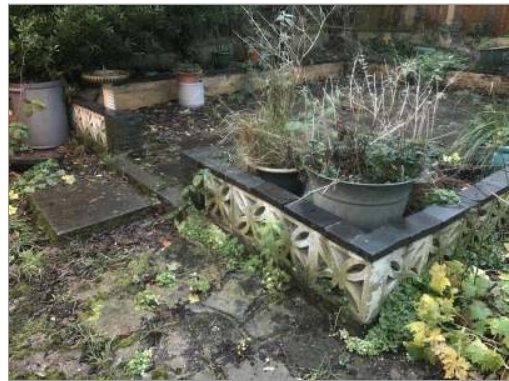
Photo - 55 Remove vegetation from raised bed areas.

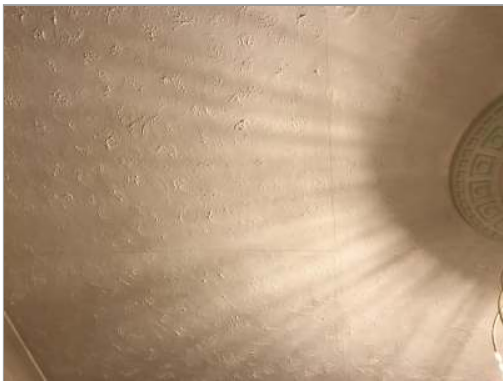
Photo - 62 Joint repairs required to artexed lounge ceiling.

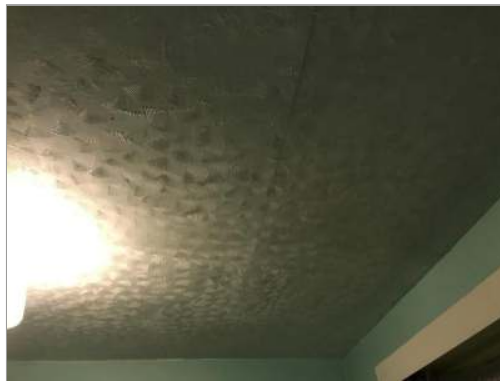
Photo - 63 Joint repairs required to rear bed 1 artexed ceiling.

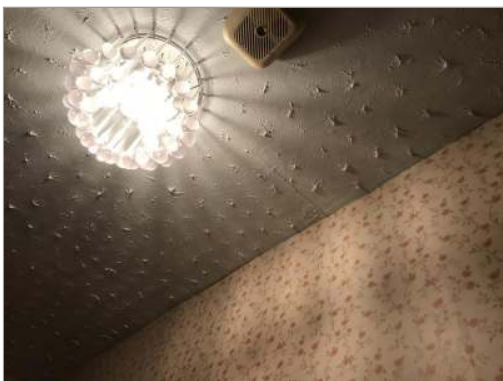
Photo - 64 Joint repairs required to artexed hallway ceiling.

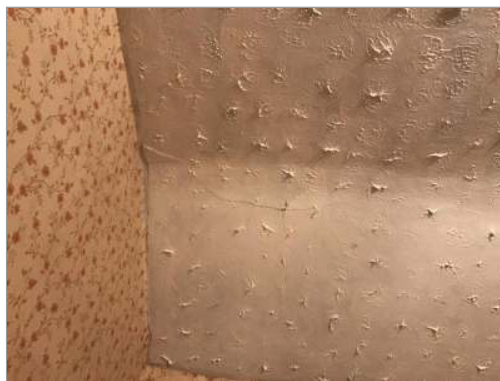
Photo - 65 Movement noted to landing staircase artexed ceiling.

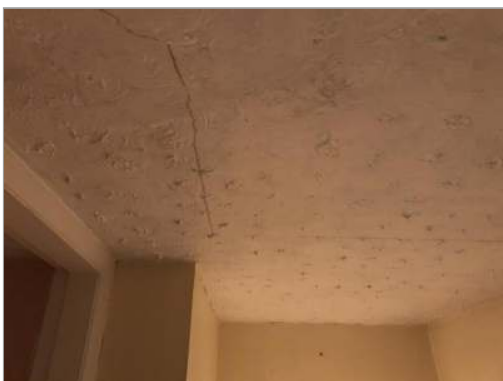
Photo - 66 Joint repairs required to artexed top floor bed 2 ceiling.

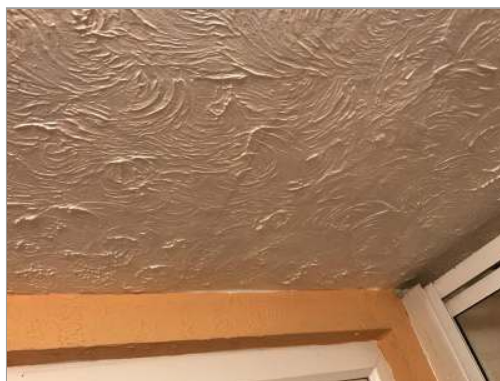
Photo - 67 Joint repairs required to artexed ensuite ceiling.

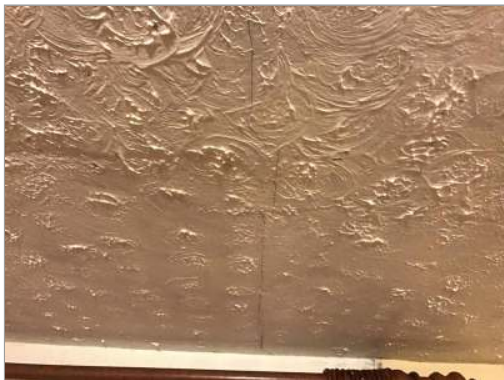
Photo - 68 Joint repairs required to artexed bed 2 ceiling.

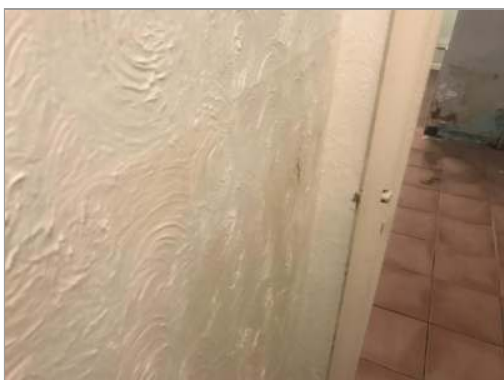
Photo - 69 Patch repairs required to artexed stud partition to bathroom and rear lobby. Test for asbestos before disturbing.

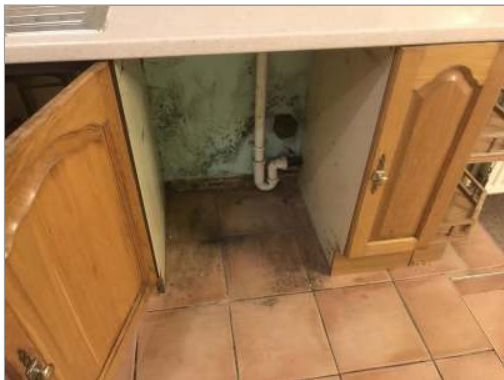
Photo - 71 Mould noted to kitchen wall.

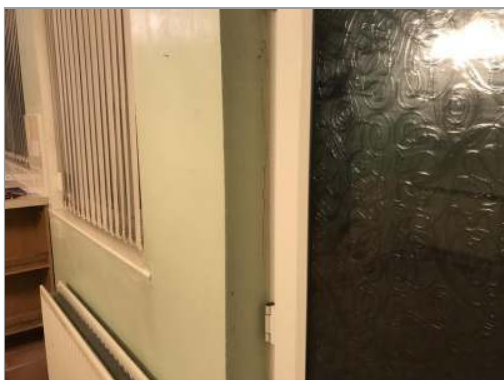
Photo - 73 Movement noted to rear door reveal.

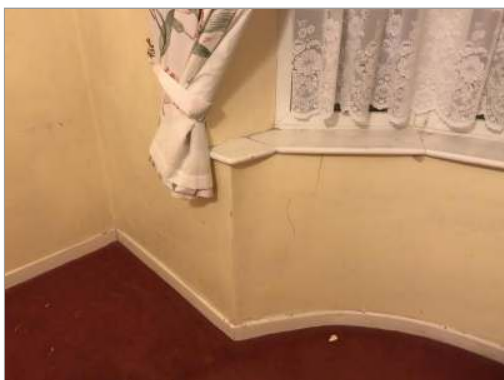
Photo - 75 Moderate movement noted to front lounge bay window wall.

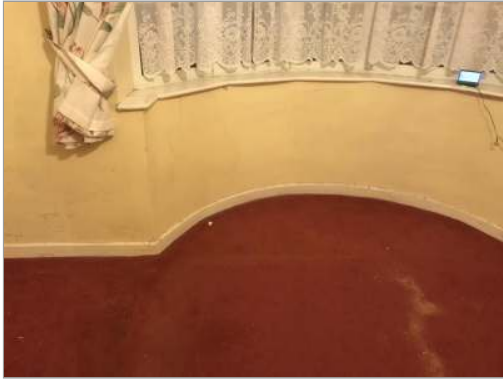
Low level blown plaster was noted to the kitchen, dining room downstairs and lounge which could be attributed to rising dampness and a bridged dpc externally. Further investigation from a damp proofing specialist will be required to substantiate this.

Photo - 77 Low level damp plaster noted to lounge.

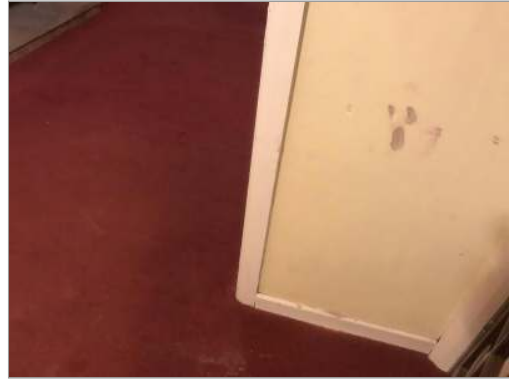
Photo - 78 Patch repairs required to lounge walls.

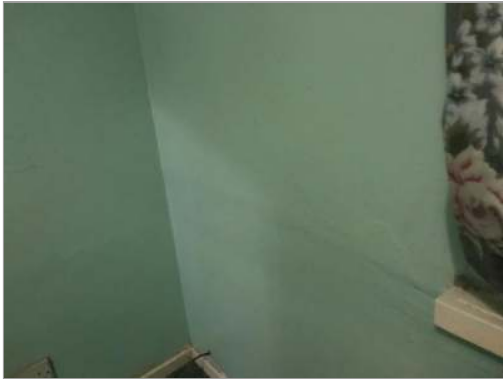
Historic movement related repairs noted to rear bed 1 window opening area.

Photo - 79 Historic movement related repairs noted to rear bed 1 window opening area.

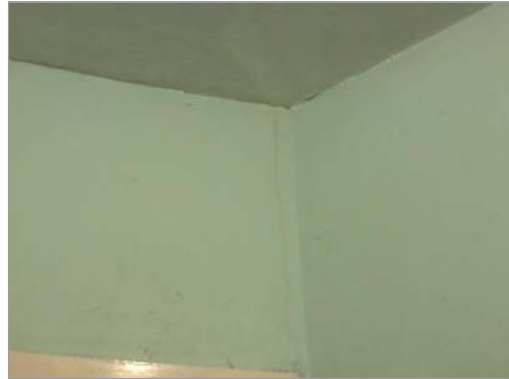
Photo - 80 Movement noted to rear bed 1 wall.

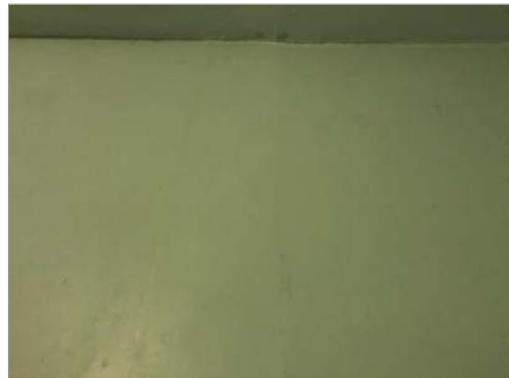
Photo - 82 Movement noted to rear bed 1 wall to side.

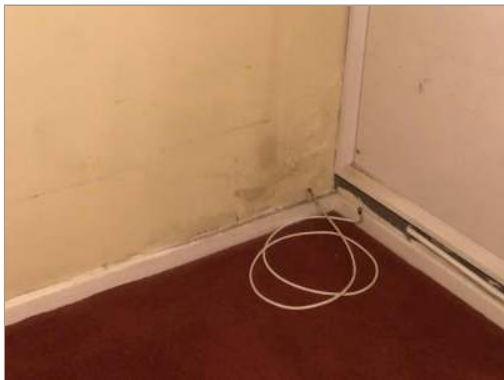
Photo - 83 Poorly plastered wall noted to bed 2.

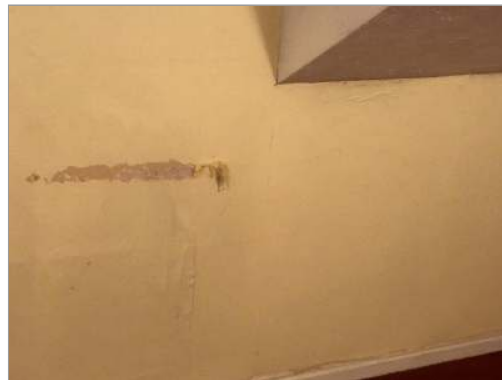
Photo - 84 Minor movement noted to rear wall to bed 2.

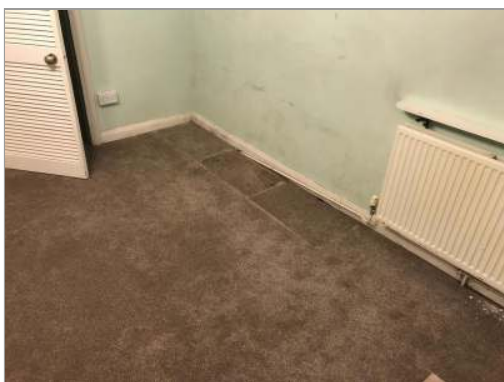
Photo - 85 Pack up sloping floor to low level kitchen.

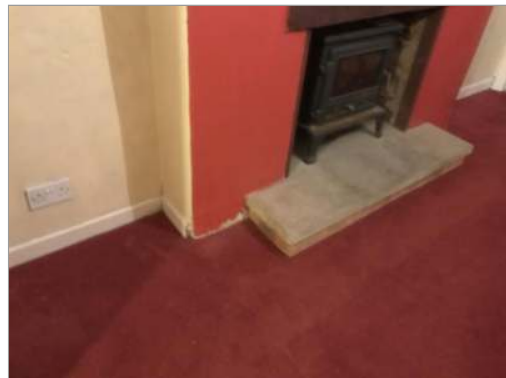
Photo - 94 Renew missing skirting to hearth.

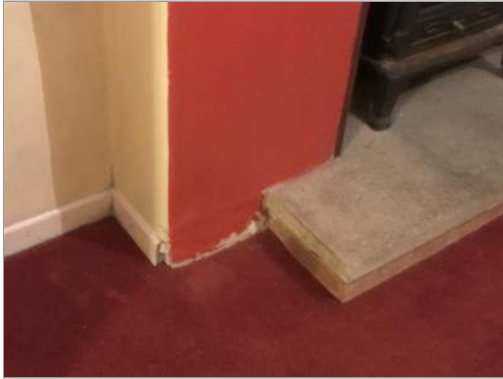
Photo - 95 Low level blown plaster noted to dining room chimney breast.m

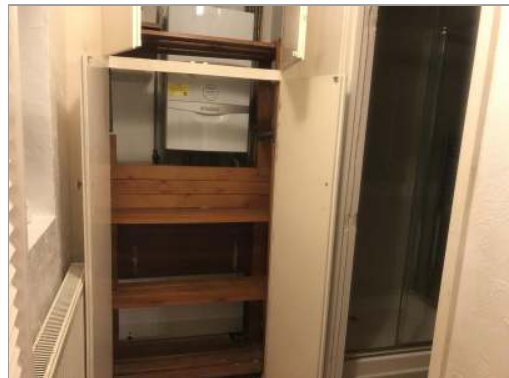
Photo - 97 Redecorate boiler cupboard.

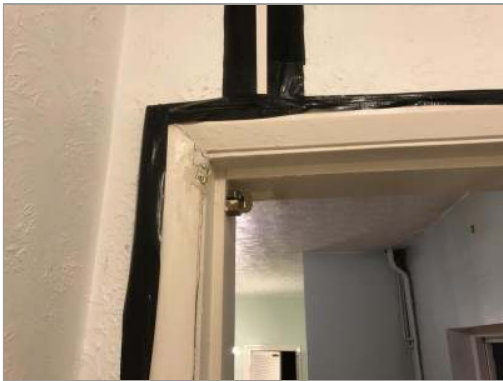
Photo - 100 Movement noted to rear lobby door frame.

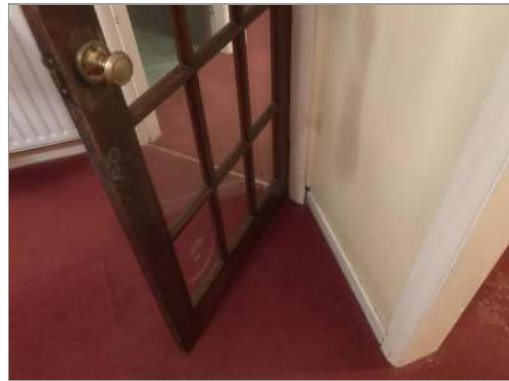
Photo - 101 Ensure internal glazing is made shatterproof.

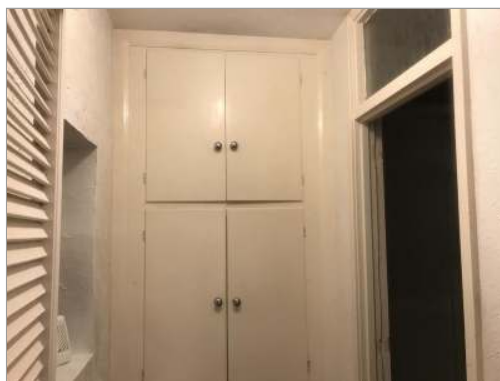
Photo - 105 Upgrade dated boiler cupboard doors.

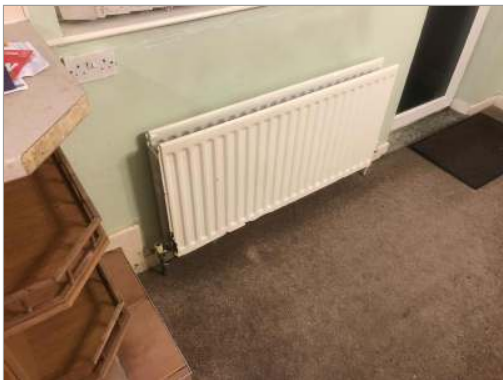
Photo - 113 Upgrade dated panel radiators to modern convector type.

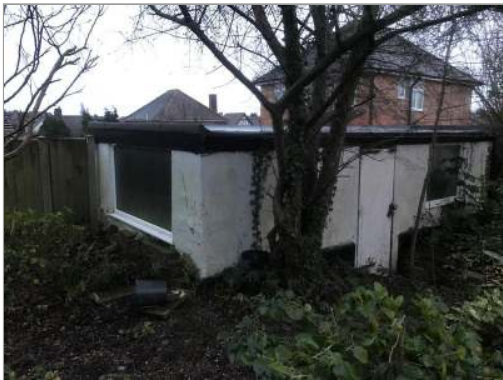
Photo - 116 Blown render noted to walls.

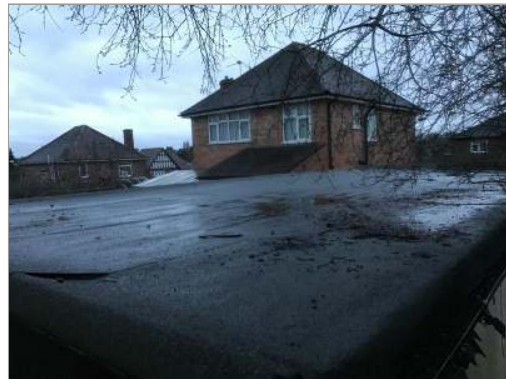
Ponding noted to flat roof. Renew felt covering to roof and remake falls.

Photo - 117 Ponding noted to flat roof. Renew felt covering to roof and remake falls.

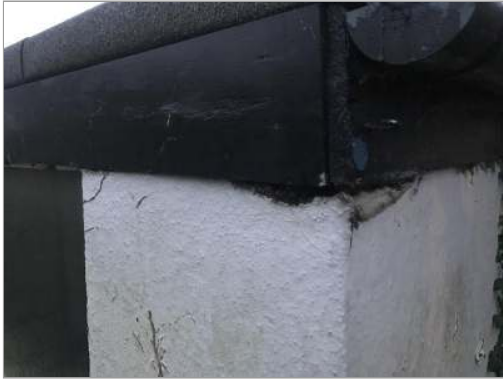
Photo - 120 Splice repairs required to rotten timbers.

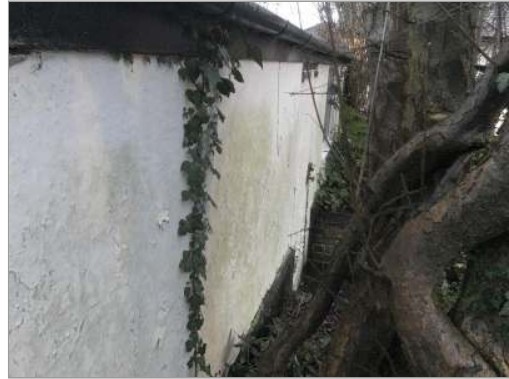
Photo - 121 Remove vegetation from walls.

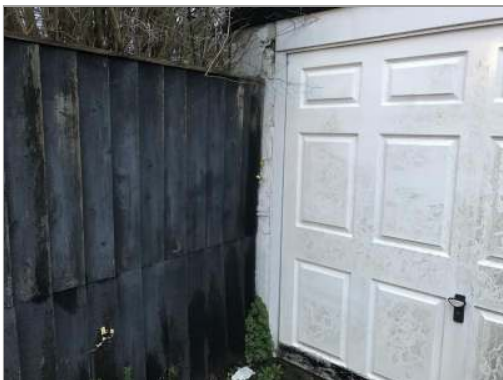
Photo - 128 Renew door which does not fully close at base. Incorrectly sized.
