Asbestos Management Survey

LOCATION:

SURVEYED ON:

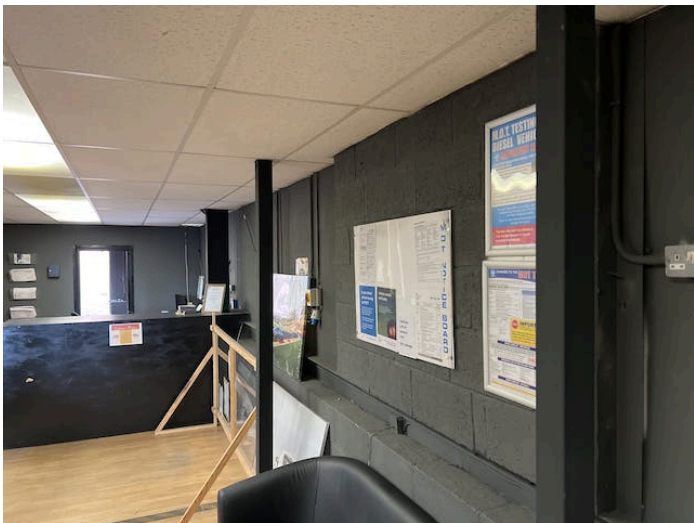
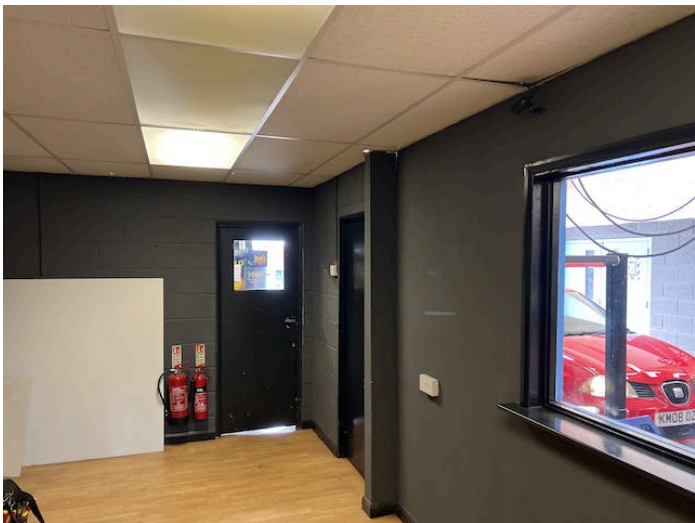
Unit 2 > 0 - Ground Floor > 003 - office > Location Notes

| Location Notes | Plasterboard and brick walls, Suspended ceiling. No samples required | | |

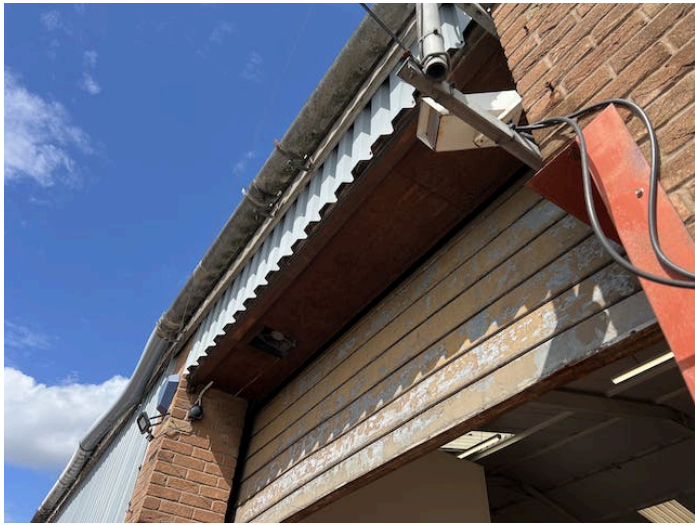
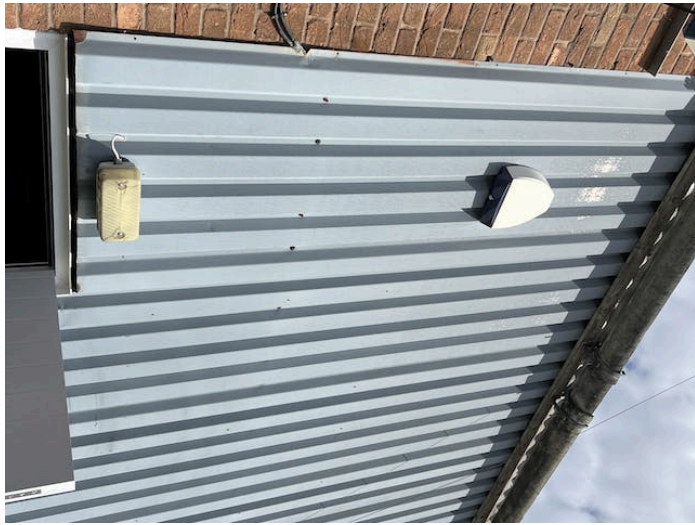
Unit 2 > 0 - Ground Floor > 004 - external > Rainwater goods

| Material | Cement | Extent | 12lm |
| Strategy / Sample Id | Strongly Presume | Presumed Fibre Type | Chrysotile |

| Material Score | 4 / Very Low | | |

| Recommendation | Reinspect annually | | |

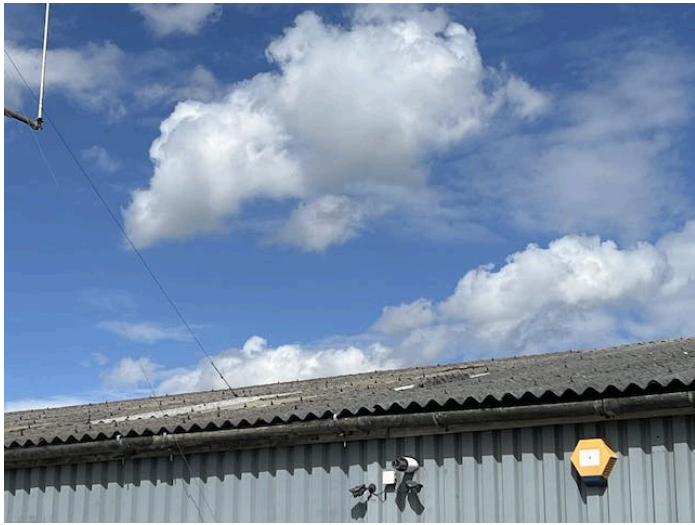
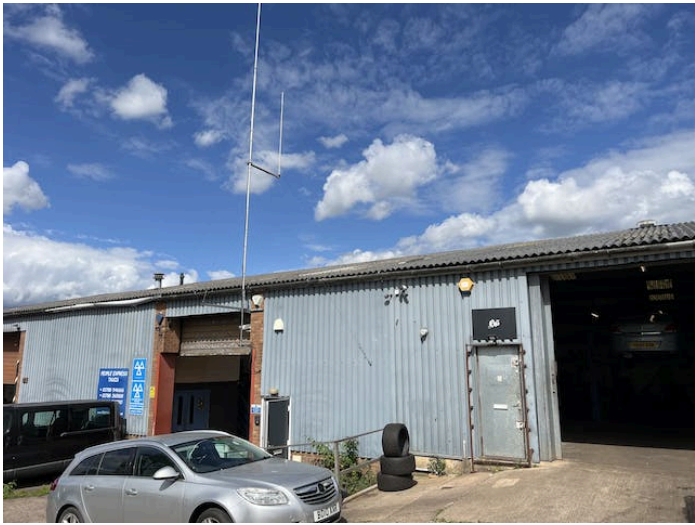
Unit 2 > 0 - Ground Floor > 004 - external > Roof

| Material | Cement | Extent | 160m2 |
| Strategy / Sample Id | Strongly Presume | Presumed Fibre Type | Chrysotile |

| Material Score | 4 / Very Low | | |

| Recommendation | Reinspect annually | | |

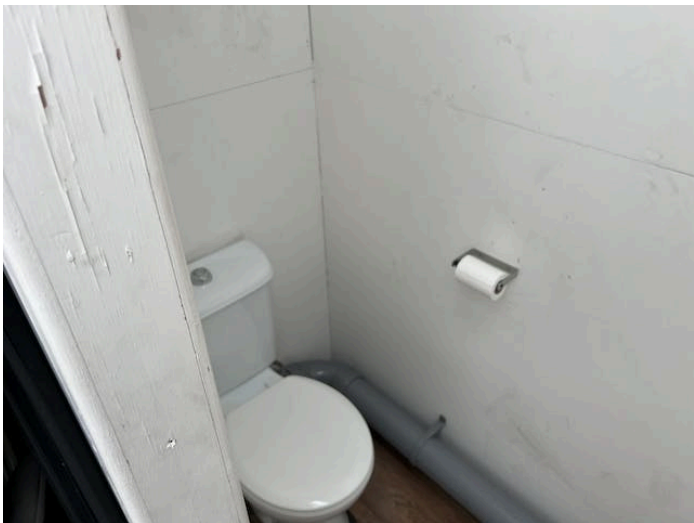
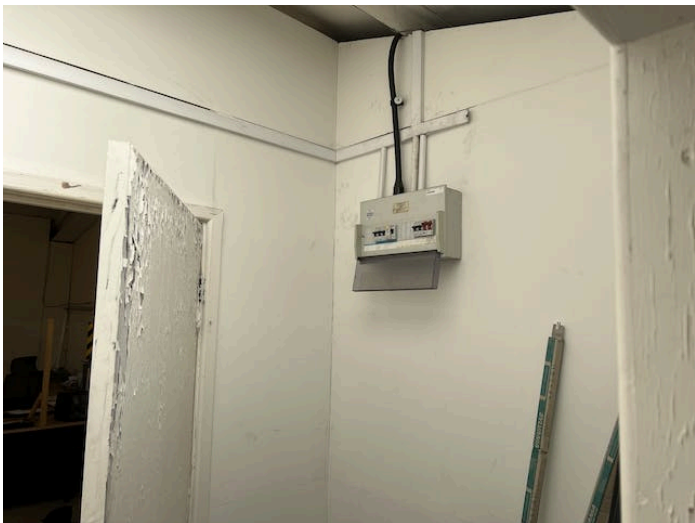
Unit 2 > 1 - First Floor > 005 - wc > Location Notes

| Location Notes | No samples required | | |

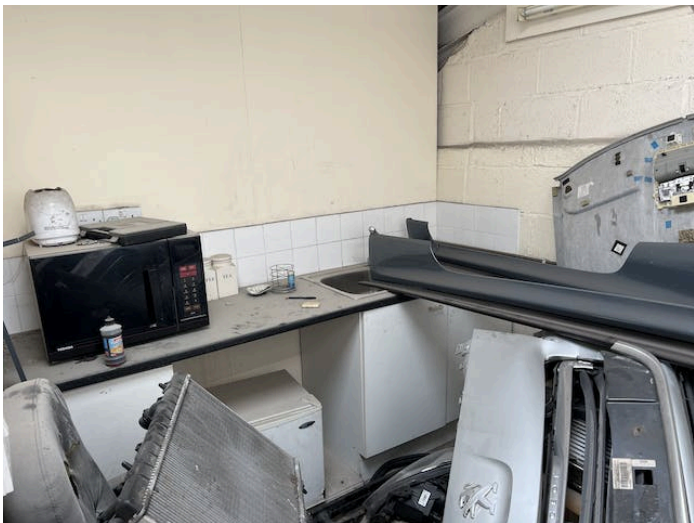
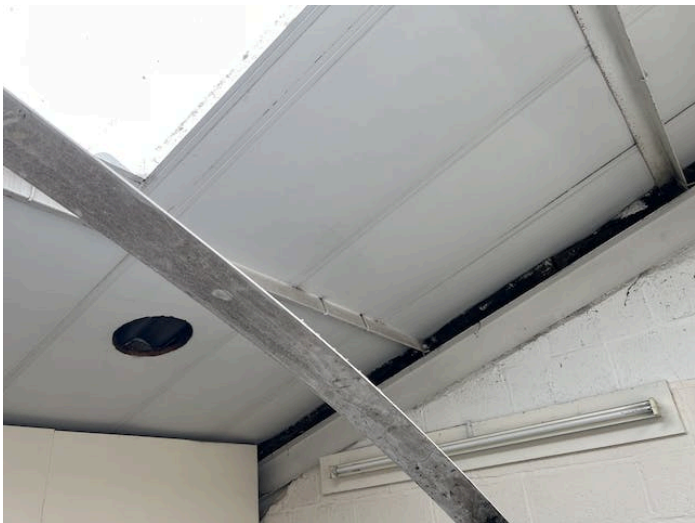
Unit 2 > Mezzanine > 001 - kitchen > Location Notes

| Location Notes | No samples required | | |
| General Comments | Brick and plaster board walls, insulation foam ceiling. | | |
