**Job Number: E-44067**

**Report Issued: 15/12/2023**

**Management  
Asbestos Survey Report  
For  
Nicola Robertson Steele  
At  
Flat 1/2, 1 Windsor Place  
Main Street, Bridge of Weir, PA11 3AF**

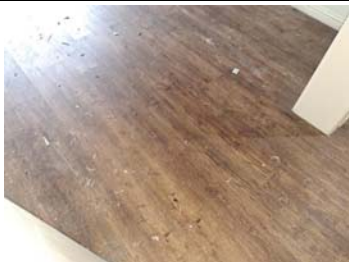
Building Name:	Flat 1/2, 1 Windsor Place	Location ID:	001	Floor / Level:	Ground Floor
Location / Room:	Main shop area

No Access Reason / Description:					
Floor - Limited access below laminate flooring					
This area should be presumed to contain asbestos until proven otherwise

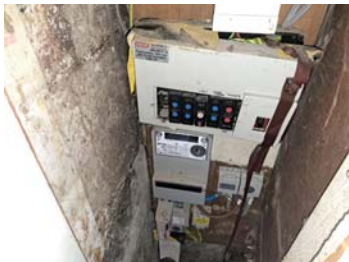
Building Name:	Flat 1/2, 1 Windsor Place	Location ID:	002	Floor / Level:	Ground Floor
Location / Room:	Electric Cupboard

No Access Reason / Description:					
Electrics - No access to live electrics					
This area should be presumed to contain asbestos until proven otherwise

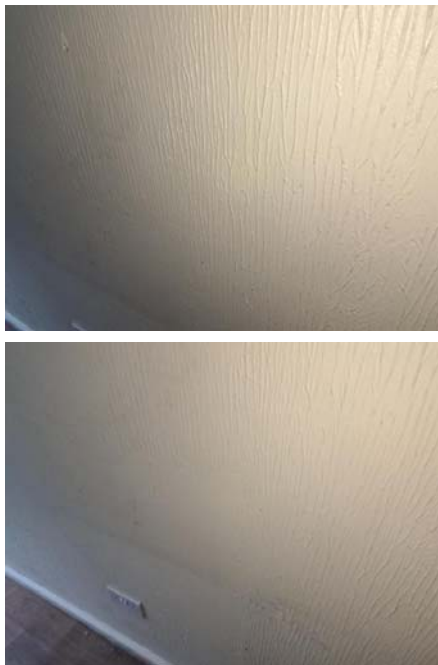
Location Code 00/001		Sample No. S001
Material Description:

Building Name:		
Location / Room:		
Floor / Level:		
Surface:		
Size :		
Condition:		
Surface Treatment:		
Analyst Result:		
Recommendation:	No Action Required

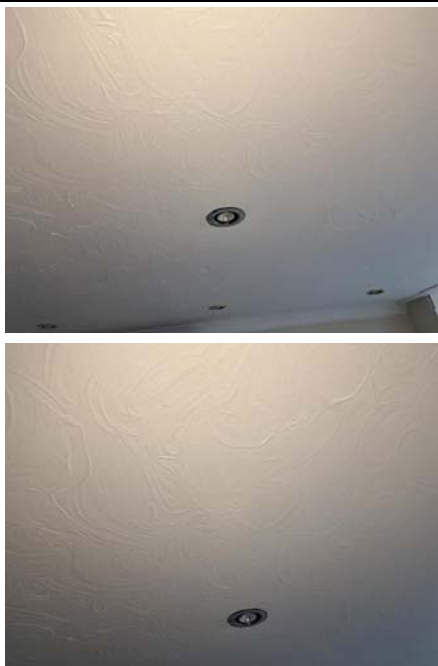
Location Code 00/001		Sample No. S002
Material Description:

Building Name:		
Location / Room:		
Floor / Level:		
Surface:		
Size :		
Condition:		
Surface Treatment:		
Analyst Result:		
Recommendation:	No Action Required

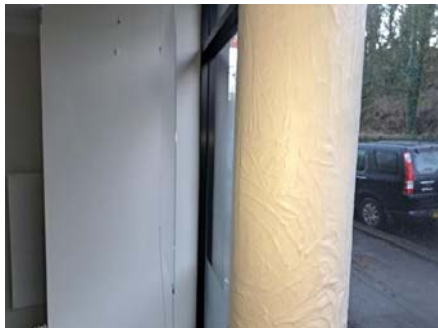
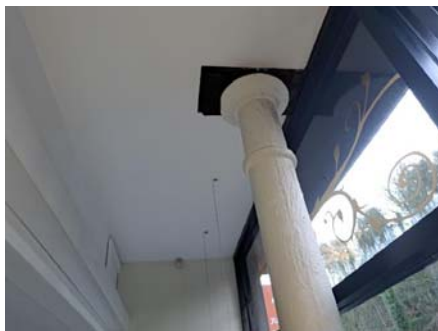
Location Code 00/001		Sample No. S003
Material Description:	Fitting - Textured Coating - Textured coating to metal column

Building Name:	Flat 1/2, 1 Windsor Place	
Location / Room:	Main shop area	
Floor / Level:	Ground Floor	
Surface:	<a href="#">Fitting</a>	
Size :	1m <sup>2</sup>	
Condition:	-	
Surface Treatment:	-	
Analyst Result:	No Asbestos Detected	
Recommendation:	No Action Required

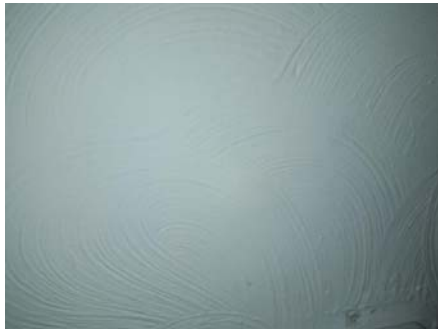
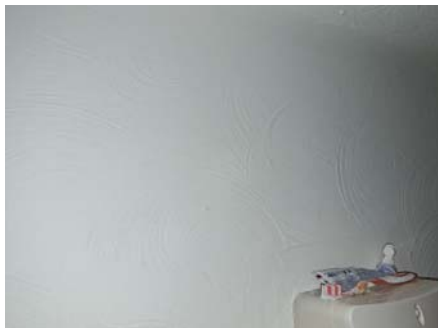
Location Code 00/005		Sample No. S004
Material Description:	Walls - Textured Coating - Textured coating to plasterboard walls

Building Name:	Flat 1/2, 1 Windsor Place	
Location / Room:	Toilet	
Floor / Level:	Ground Floor	
Surface:	<a href="#">Walls</a>	
Size :	4m <sup>2</sup>	
Condition:	-	
Surface Treatment:	-	
Analyst Result:	No Asbestos Detected	
Recommendation:	No Action Required
