ASBESTOS SURVEYING REPORT

Asbestos Inspection Report (HSG 264) Management Survey

364 Barlow Moor Road
Manchester
M21 8AS

Surveyed by Ian Watson on 4 Jul 2024

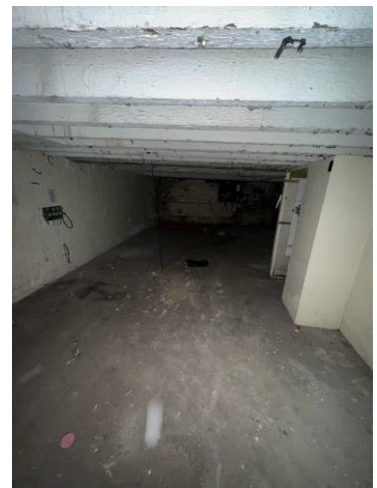
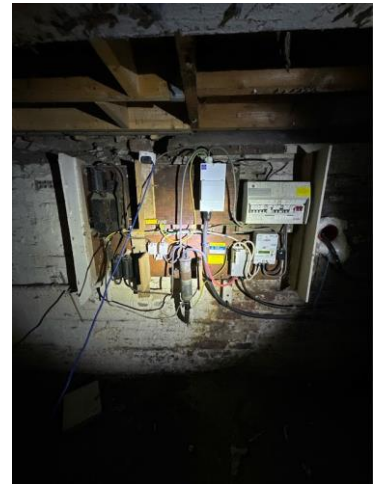
Area	Features	Photo
0-Ground floor > Retail Area Vacant Retail Unit	Floor Type: Timber Wall Type: Plaster , Solid Wall Ceiling Type: Plasterboard	 
0-Ground floor > WC Washroom Facilities	Floor Type: Tiled Wall Type: Partition Walls , Half Tiled Walls Ceiling Type: Plasterboard

0-Basement > Basement
Void Basement

Floor Type: Concrete , Solid
Flooring
Wall Type: Brick
Ceiling Type: Timber

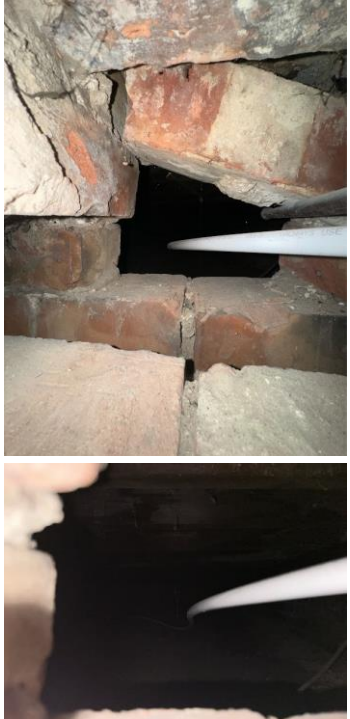
Excluded Area	Photo
0-Basement > Basement Room <i>Void under fire place and toilets. No access available</i>

Non accessed area. This area should be surveyed prior to refurbishment or demolition.

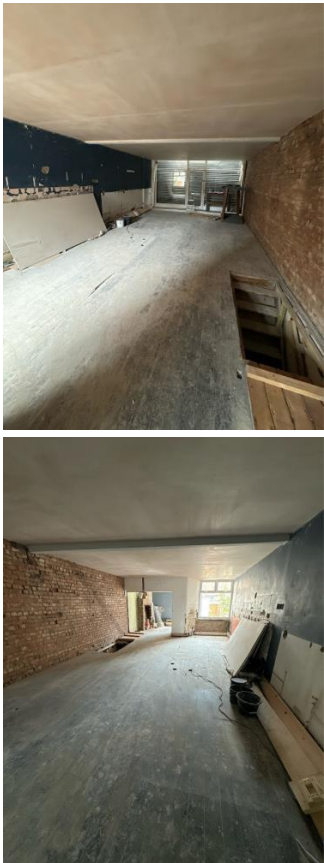
Non Asbestos Area/Item	Justification	Photo
0-Ground floor > Retail Area Room	<i>No Asbestos Detected</i> Area inspected in detail and no suspected asbestos containing materials identified.

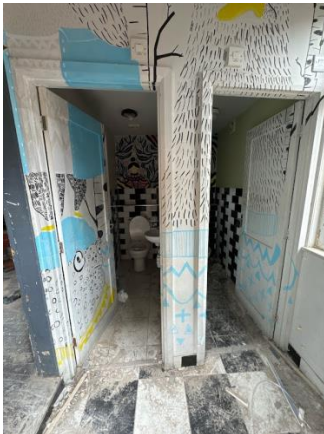
0-Ground floor > WC Room	<i>No Asbestos Detected</i> Area inspected in detail and no suspected asbestos containing materials identified.

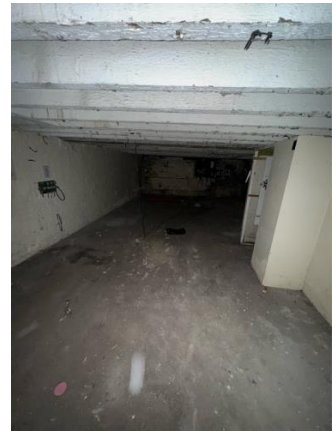
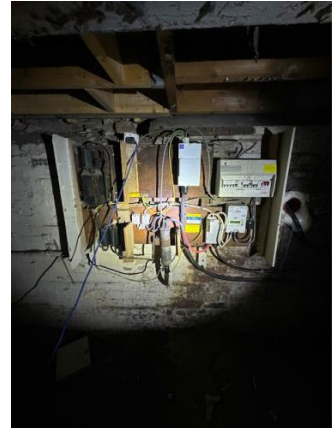
0-Basement > Basement
Room

No Asbestos Detected
Area inspected in detail and no
suspected asbestos containing
materials identified.
