RICS
HomeBuyer Report...

77 Water Street
Kingswinford
West Midlands
DY6 7QD.

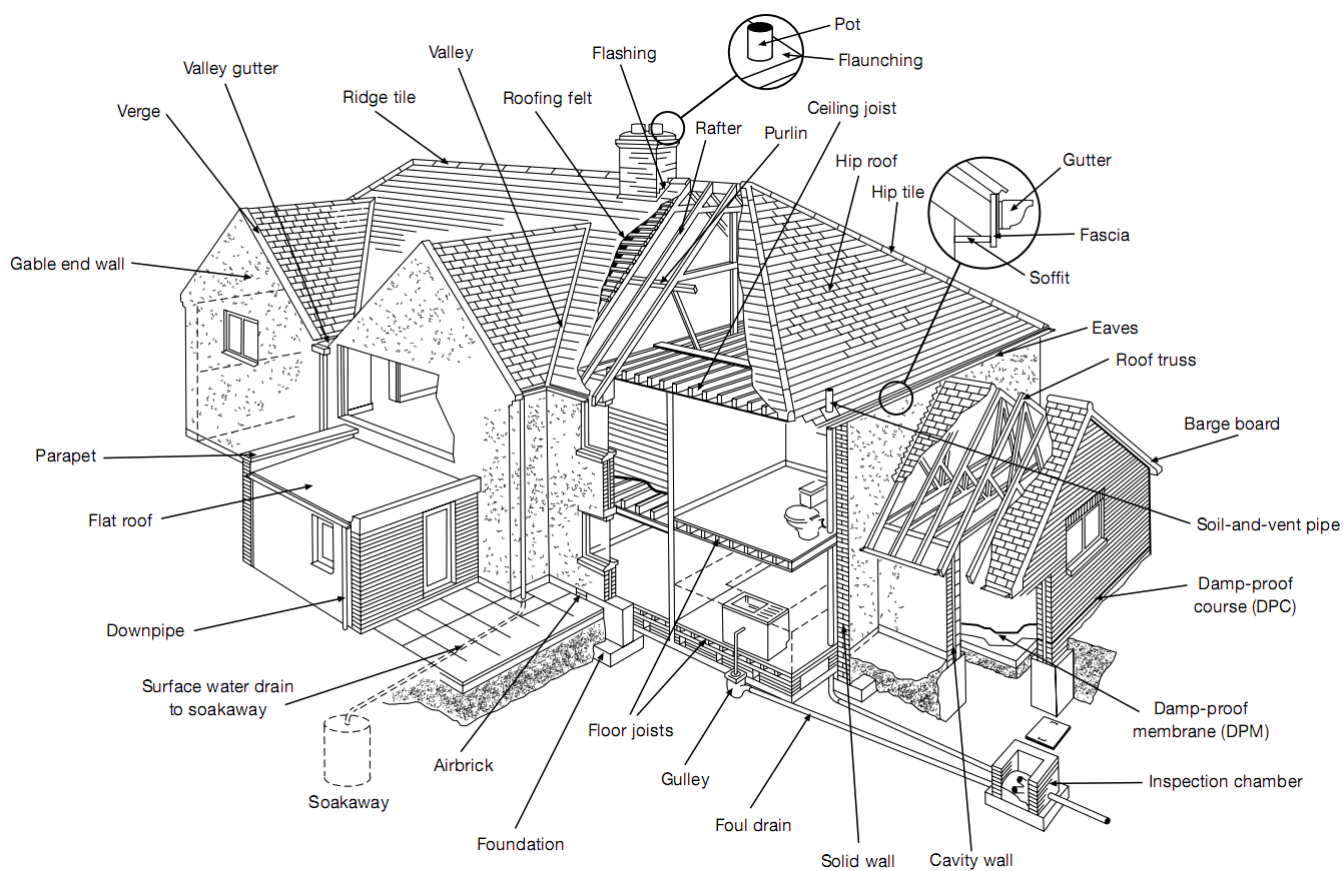
Typical house diagram

This diagram illustrates where you may find some of the building elements referred to in the report.
