RICS Home Surveys Building Survey

39 Bentley Avenue, Bakersfield,
Nottingham, NG3 7AX

20th January 2021

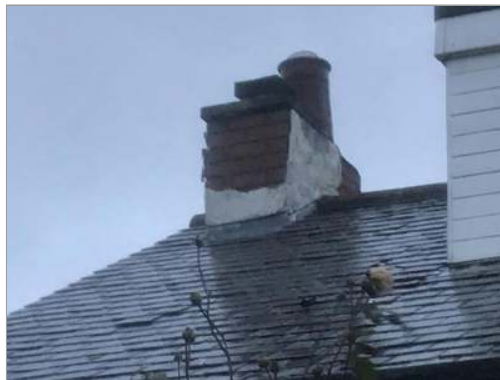
Photo - 2 Leaning stack. Structural monitoring required.

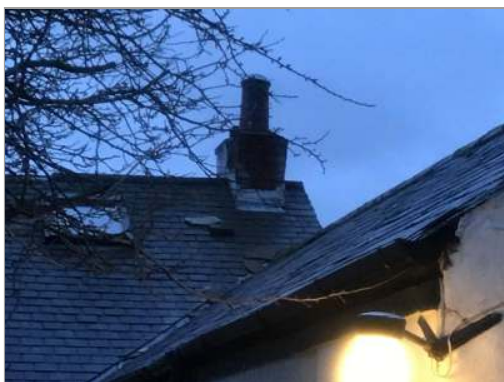
Photo - 3 Redress flashings, Repoint work brickwork.

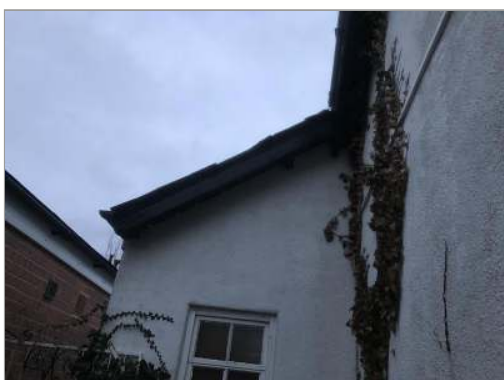
Photo - 8 Repoint verges.

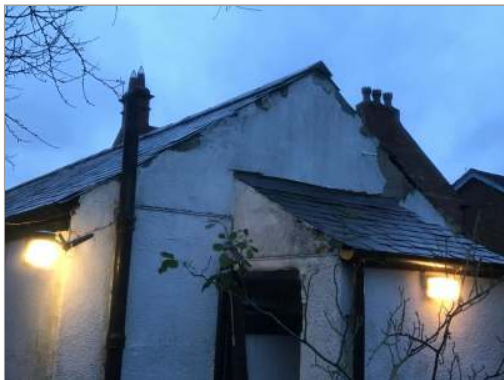
Photo - 10 Repoint verge.

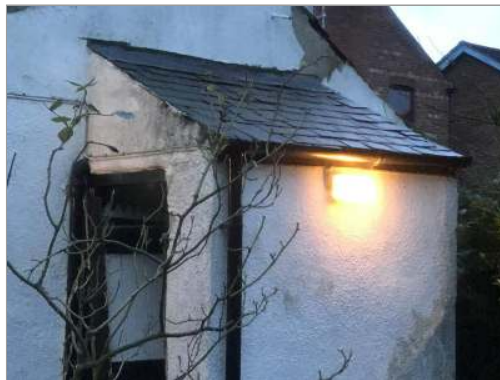
Photo - 11 Refix slipped slates to rear outhouse. Or renew.

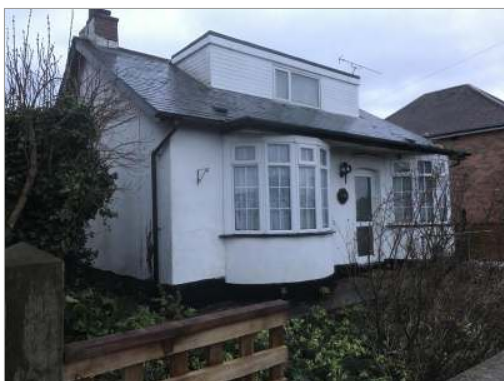
Photo - 12 Upvc rainwater goods appear functional.

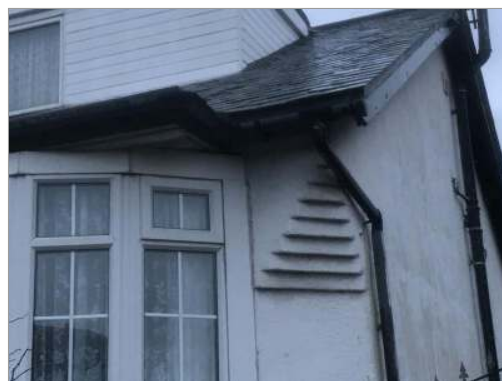
Photo - 13 Renew faded sections for aesthetic purposes.

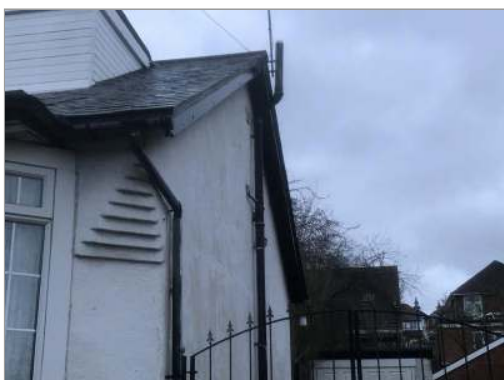
Photo - 14 Upvc soil stack.

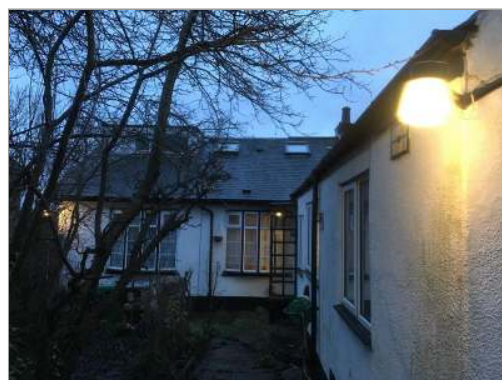
Photo - 15 Unblock rear gutters.

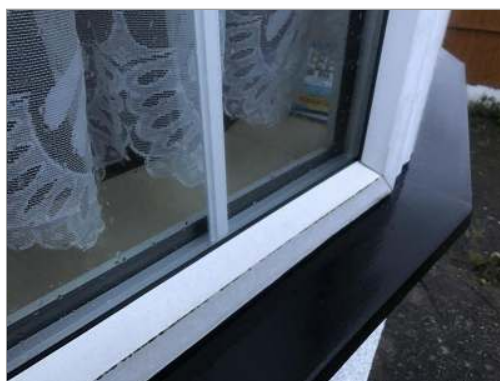
Photo - 25 Upvc double glazed windows appear functional but are externally beaded which may be a security concern.

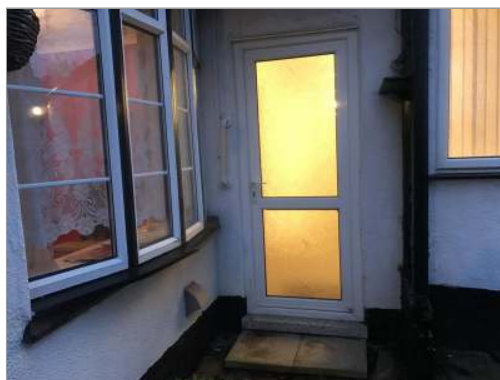
Photo - 32 Rear upvc door noted too.

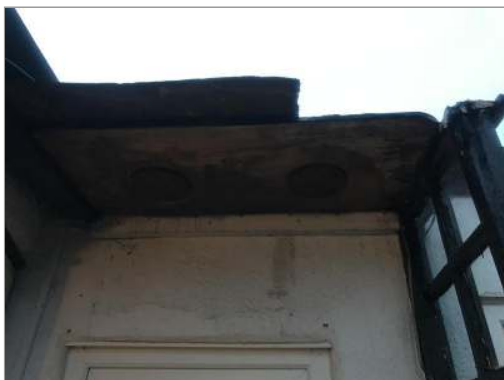
Photo - 33 Renew dilapidated rear door canopy.

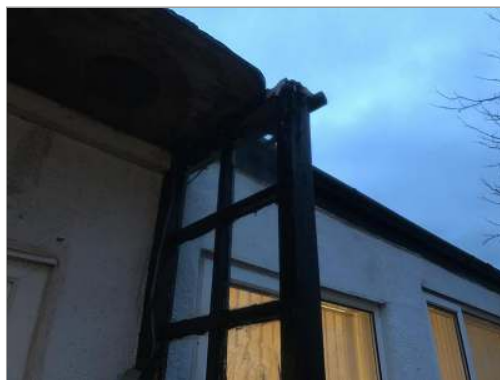
Photo - 34 Timber single glazed rear porch frame requires upgrading.

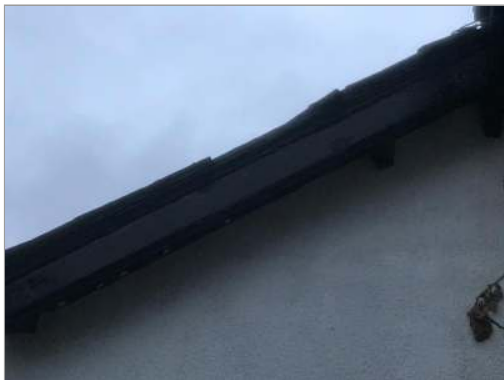
Photo - 35 Timber fascias and soffits noted.

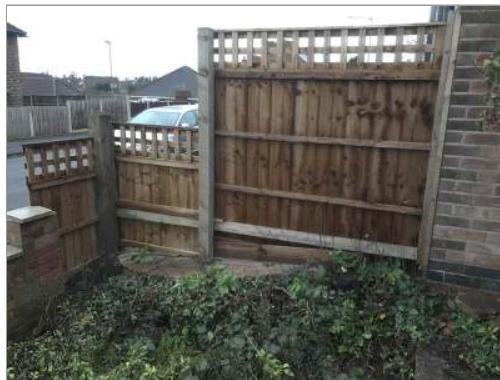
Photo - 36 Redecorate timber fence lines to front.

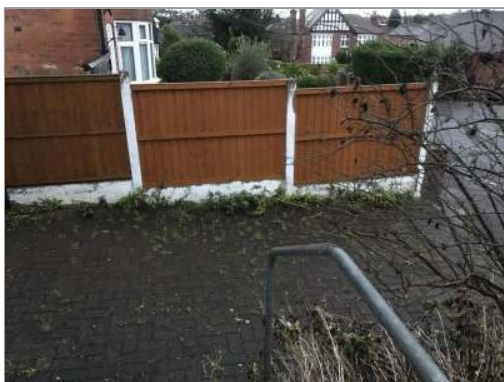
Photo - 37 Redecorate timber fence line to front.

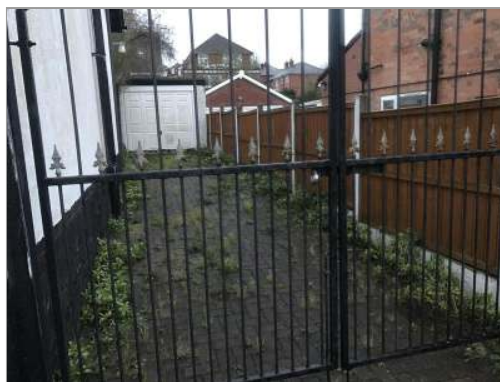
Photo - 38 Redecorate rear timber fenceline.

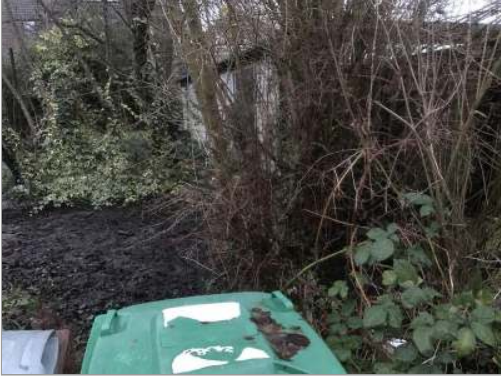
Photo - 41 Check for invasive weeds.

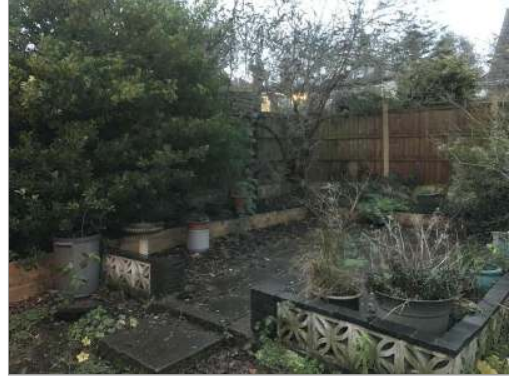
Photo - 42 Redecorate rear timber fence lines.

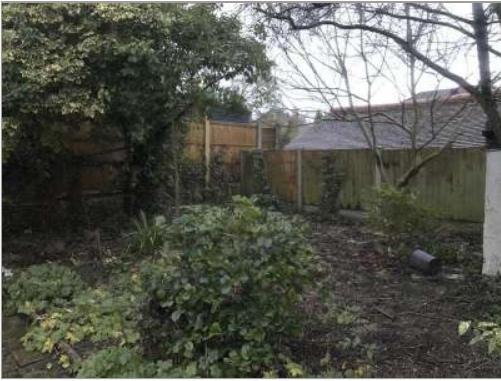
Photo - 43 Remove vegetation from rear timber fence lines.

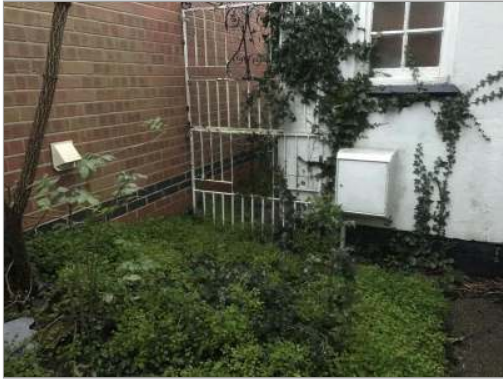
Photo - 44 Rub down and redecorate metal gate to side elevation.

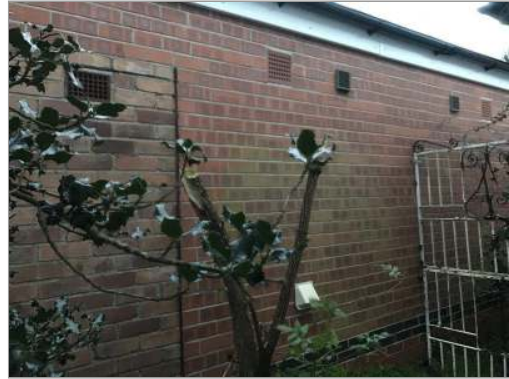
Photo - 45 Bricked up door noted to neighbouring structure.

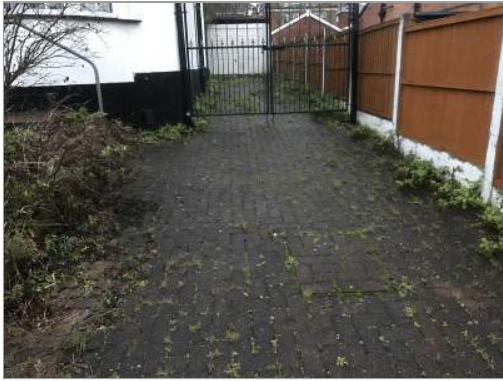
Photo - 52 Remove vegetation from front pavers and rebed.

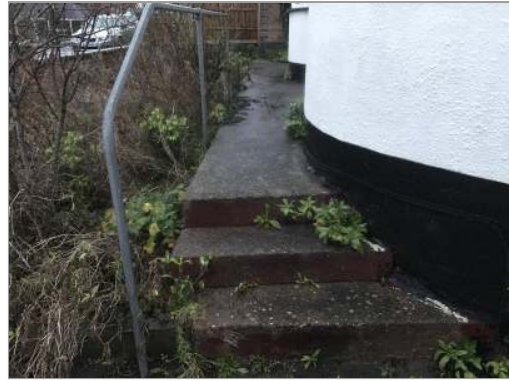
Photo - 53 Remove vegetation from steps.

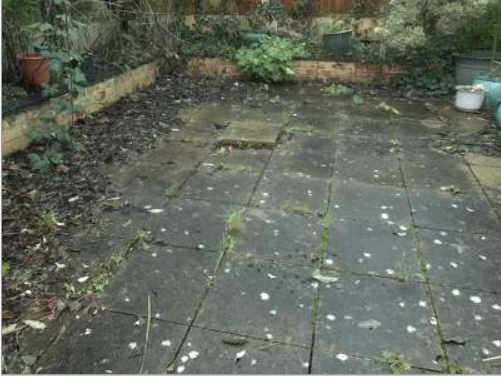
Photo - 56 Remove vegetation from pavers and rebbed to rear.

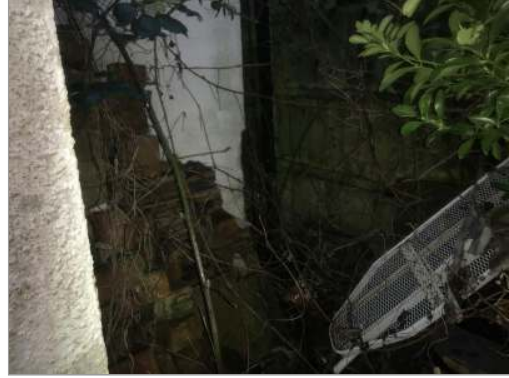
Photo - 57 Limited access to side.

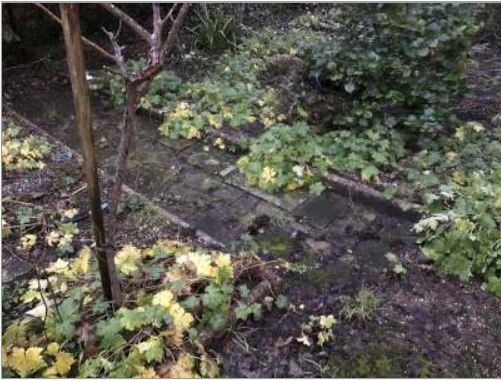
Photo - 58 Check for invasive weeds.

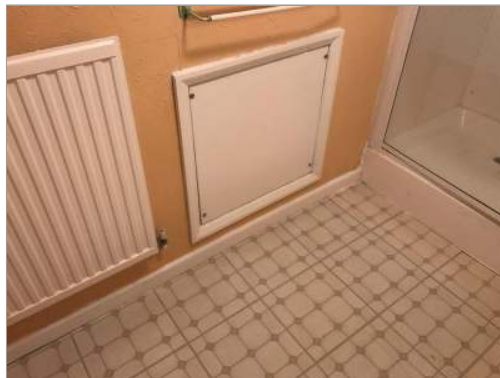
Photo - 60 Eaves hatch to ensuite is screwed shut.

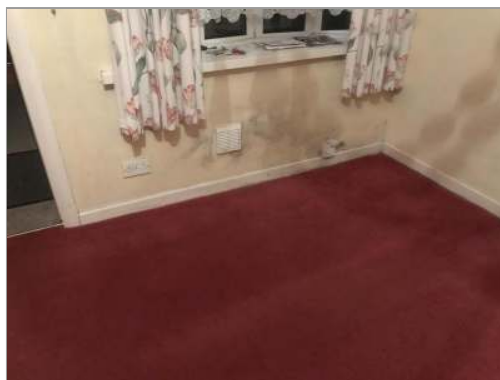
Photo - 74 Low level damp plaster and mould noted to dining room.

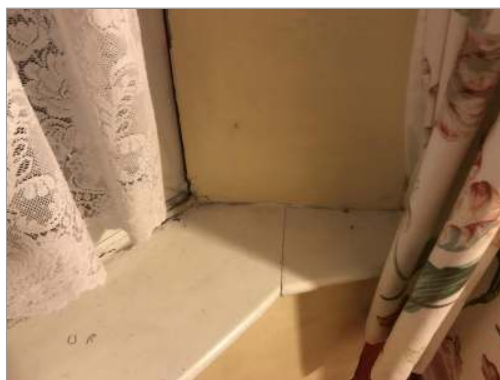
Photo - 76 More movement noted. Structural engineering consultation required.

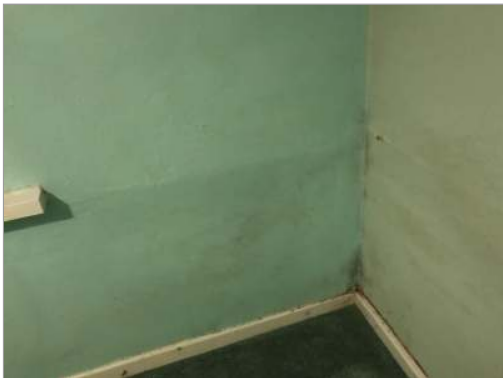
Photo - 81 Low level blown plaster noted to rear bed 1.

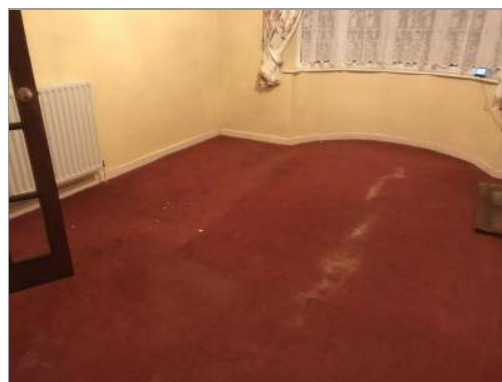
Photo - 86 Pack up sloping floor to lounge.

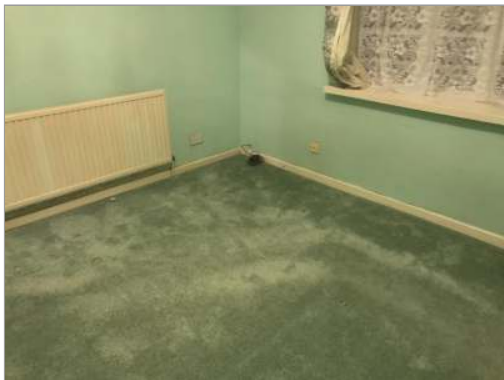
Photo - 87 Pack up sloping floor to rear bed 1.

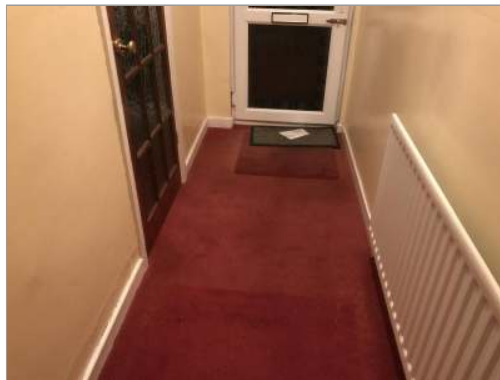
Photo - 88 Pack up sloping floor to landing.

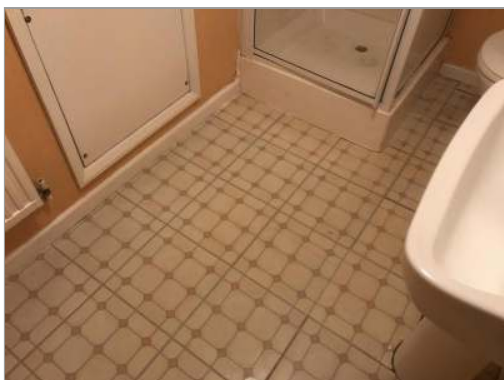
Photo - 89 Pack up sloping floor to ensuite.

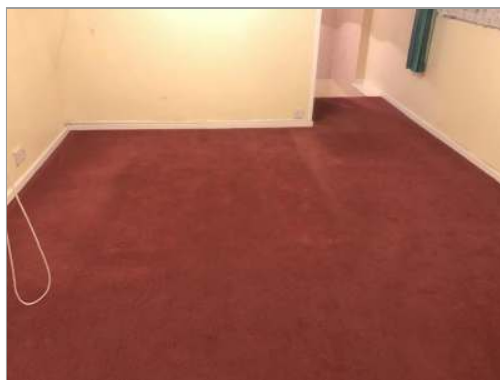
Photo - 90 Pack up sloping floor to top floor bedroom.

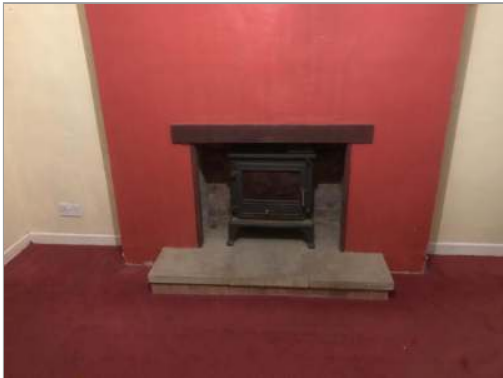
Photo - 91 Open fire noted to dining room.

You should ensure all fuel based fittings are tested before use. You should ensure that the flues are properly lined and in a safe condition prior to use (HETAS tested). The flues have not been inspected and it is not possible to comment upon the adequacy of any linings. If you intend to use any of these fireplaces they would also require sweeping and adequate hearths etc., provided.

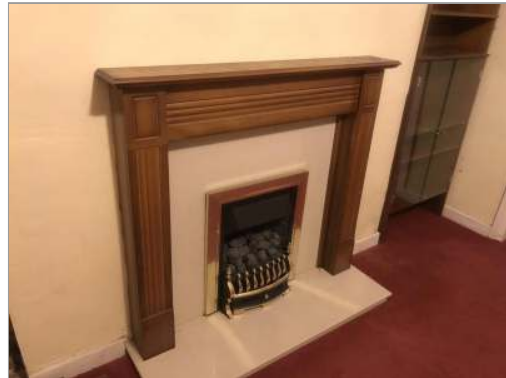
Photo - 92 Gas fire noted to lounge.

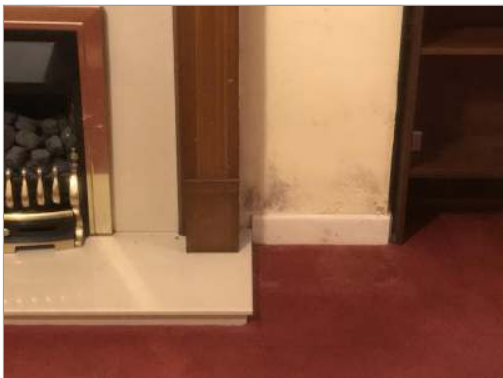
Photo - 93 Low level blown plaster noted to lounge chimney breast.

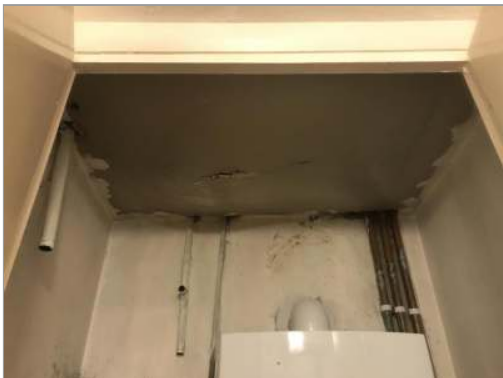
Penetrative dampness noted to boiler cupboard from pitched roof above.

Photo - 96 Penetrative dampness noted to boiler cupboard from pitched roof above.

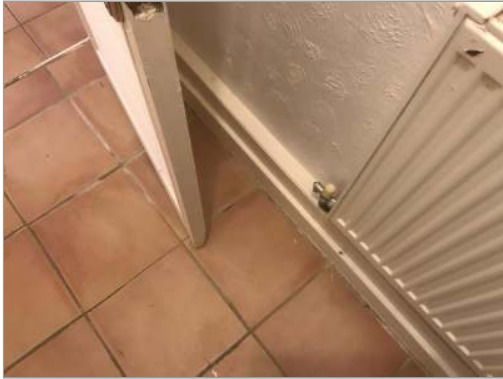
Photo - 98 Install door stops to internal doors.

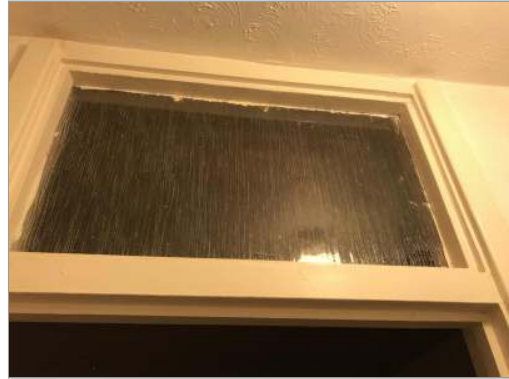
Photo - 99 Ensure internal glazing is made shatterproof.

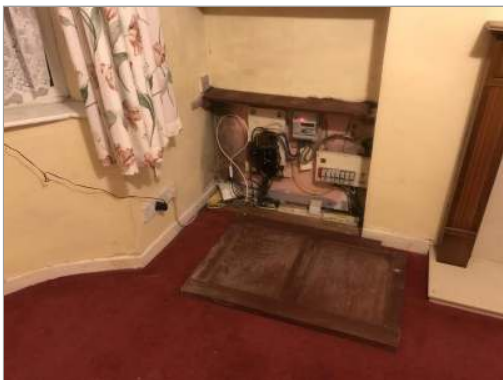
Photo - 102 Refix lounge meter cupboard.

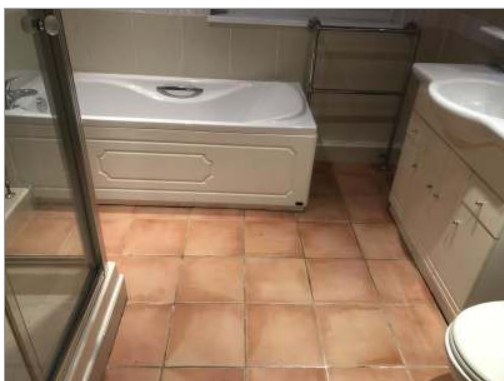
Photo - 104 Modern four piece bathroom noted to rear of property.

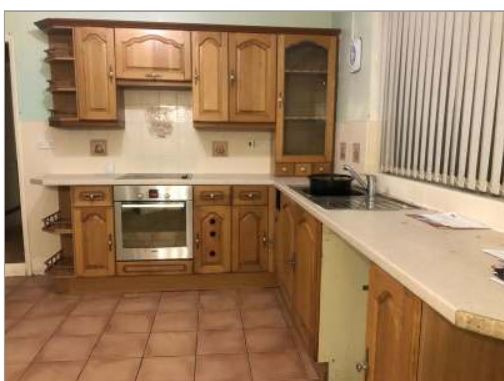
Photo - 106 Kitchen appear semi modernised.

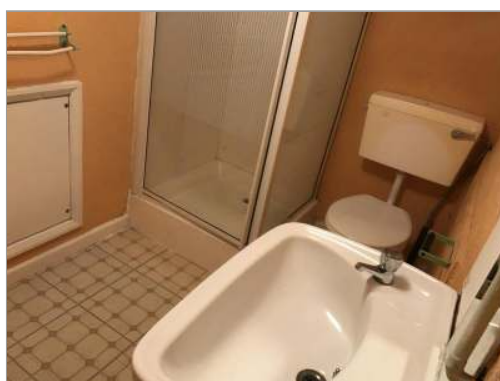
Photo - 107 Ensuite to bed 2 requires modernisation.

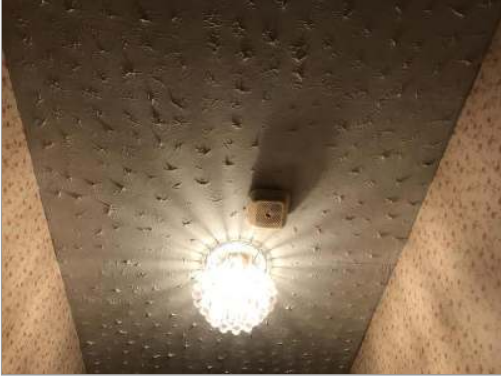
Photo - 108 Smoke detector noted to hallway.

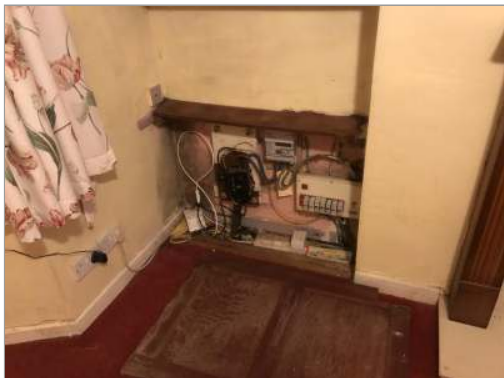
Photo - 109 Upgrade dated fusebox to lounge meter cupboard to split load rcd protected consumer unit.

Mains electricity supply is installed, with an external meter and consumer unit located internally. The observed wiring and fittings appear to be relatively modern, but current guidelines recommend that electrical installations should be tested every five years or upon change of ownership and you should strictly adhere to this advice. If no guarantees etc are available, then the system should be tested by a qualified electrician (preferably NICEIC/NCA registered), prior to entering into any legal commitment to purchase.

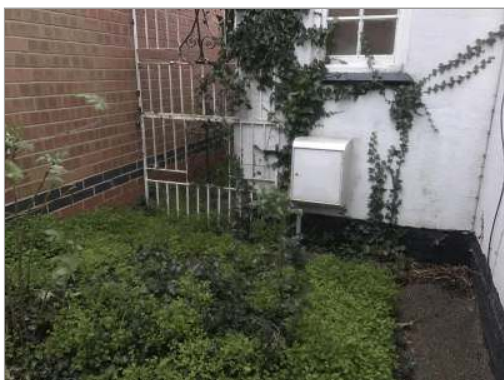
Photo - 111 Gas meter noted to side.

Mains gas appears to be connected. In view of the complexity of regulations and safety implications, we recommend an inspection of the installation etc. by the appropriate gas company.

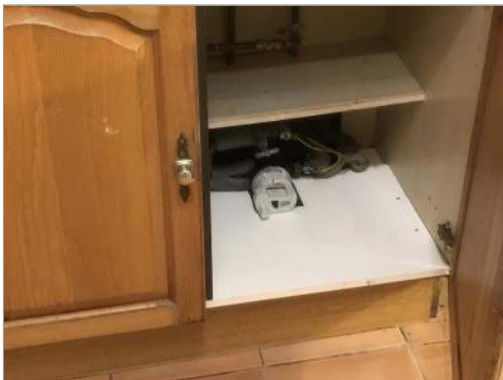
Photo - 112 Water meter and stop tap noted to base unit.

Consider upgrading stop tap to a sure stop.

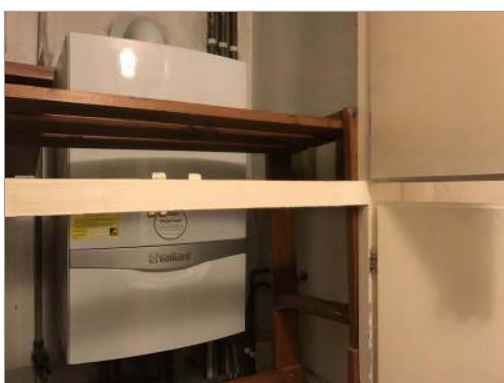
Photo - 114 Modern combi boiler noted to rear airing cupboard adjacent to bathroom.

You should confirm if there are any maintenance records for the domestic hot water system and, if not, it should be tested by a Gas Safe Registered Gas engineer, prior to entering into any legal commitment to purchase with all recommendations implemented.

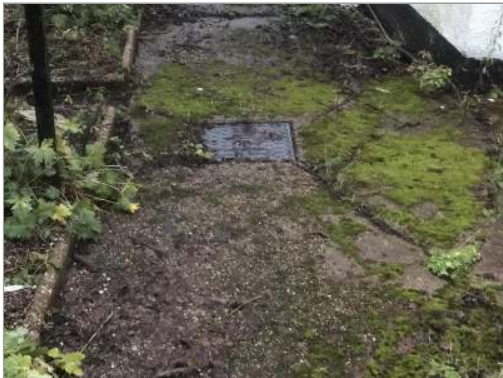
The ground around the manhole looks like it has been affected by movement hence the need to patch repair around the benching and the emanating diagonal cracks around it. You are advised to undertake a CCTV scan of the drainage runs in case a broken drain is allowing water to seep underground and wash away the foundations causing further ground movement.

Photo - 115 Rear manhole.

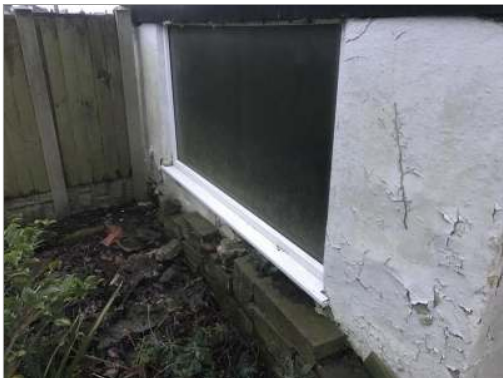
Photo - 118 Upgrade window for security purposes.

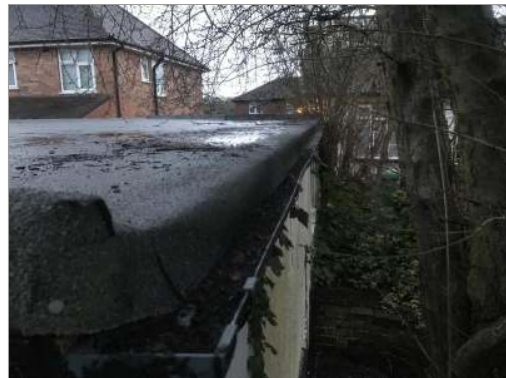
Photo - 119 Unblock upvc gutters.

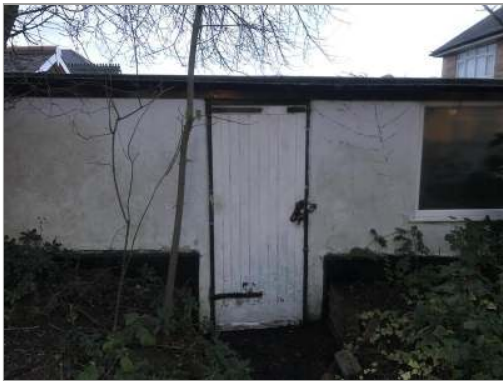
Photo - 122 Upgrade timber door for security purposes.

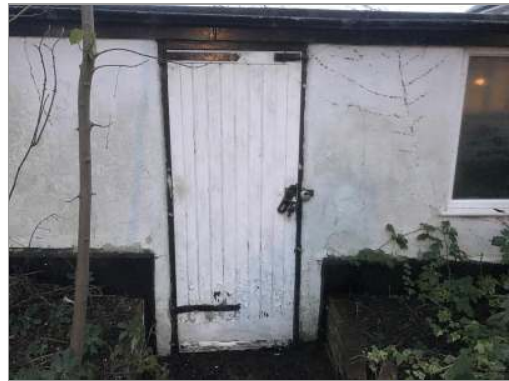
Photo - 123 Check for invasive weeds.

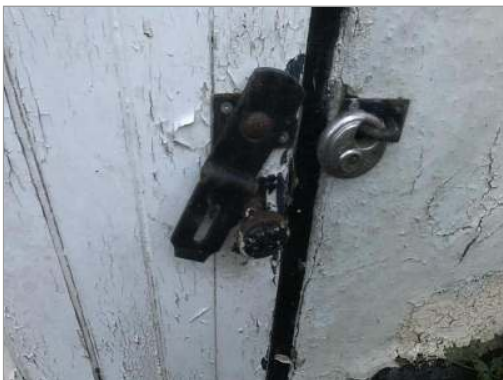
Photo - 124 Door stuck

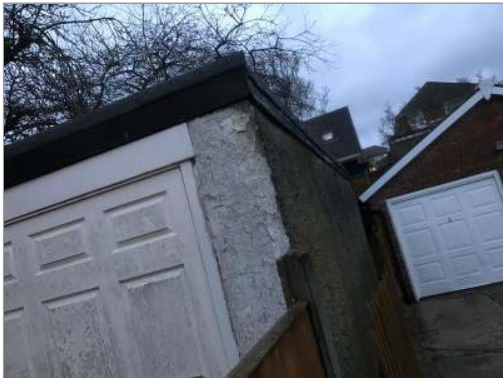
Photo - 126 Blown concrete noted.

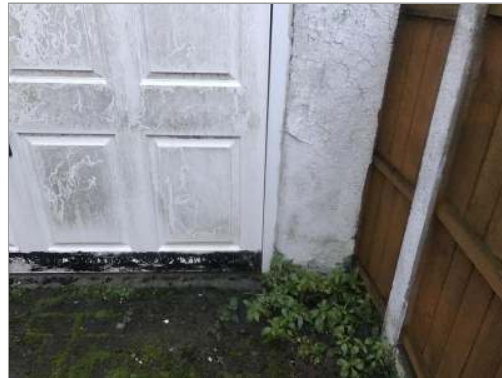
Photo - 127 Remove vegetation and low level rising dampness noted.
